Transport  
Canada

TP 185E  
Issue 3/2014

# AVIATION SAFETY LETTER

## Bell 204 Tail Rotor Pitch Link Bolt Failure...

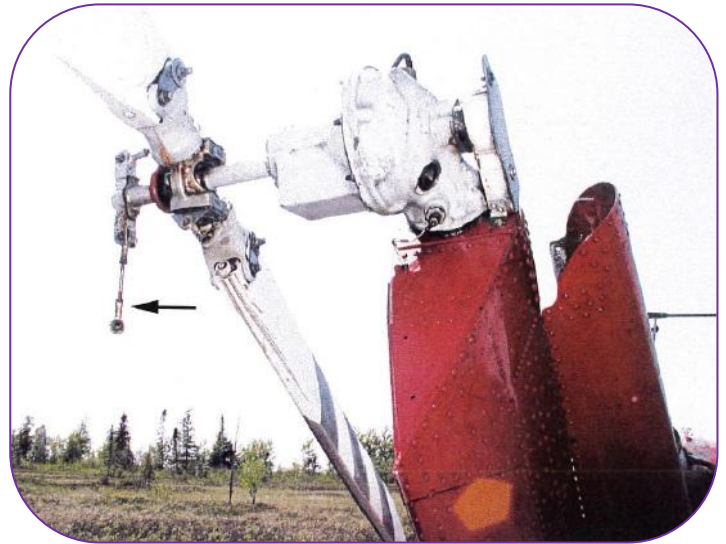
Post-flight examination revealed that one of the tail rotor pitch change link bolts was missing; the pitch change link was hanging free from the tail rotor blade grip horn (see Photo 1), but the link was still attached on the opposite end of the crosshead assembly. The disconnected tail rotor blade had struck the vertical stabilizer several times in flight, causing the banging noise heard by the pilot and the damage to the stabilizer.

*Photo 1: Detached pitch link—2003 occurrence*

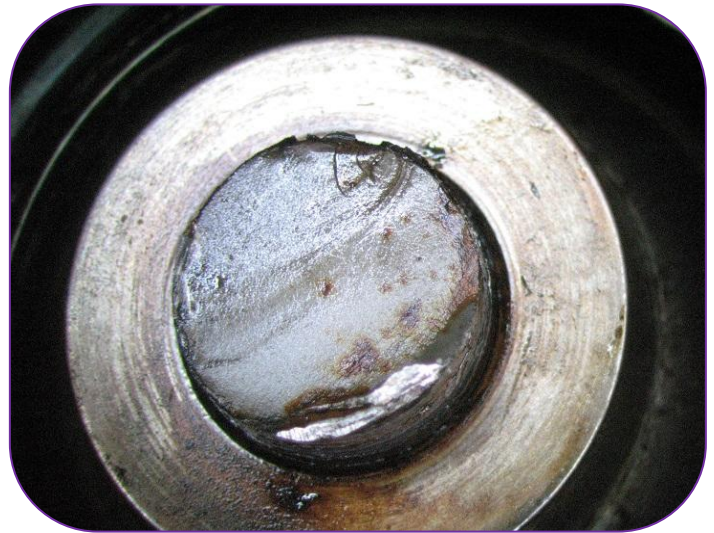
The tail rotor assembly was installed as an overhauled unit on July 7, 2002, and had accumulated approximately 211 hr of time in service. The tail rotor pitch link bolts and attachment hardware were transferred from the old tail rotor assembly to the new one at the time of installation. The pitch change link bolts are not lifed items and are controlled as on-condition items. As such, it is not known how long the bolts had been in service at the time of occurrence. Although the pitch change link bolt was not recovered, the wear pattern on the tail rotor blade grip horn pitch change bushings was indicative of an under-torqued or loose bolt arrangement.

*Photo 2: Close-up of the fractured bolt.*

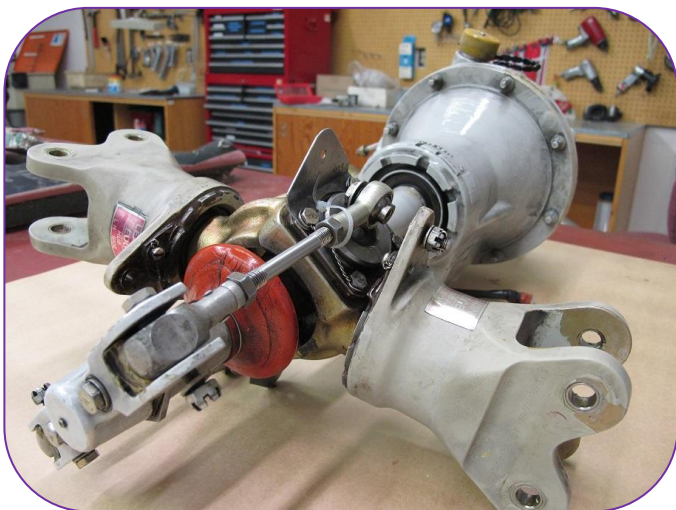
*Photo 3: Tail rotor assembly with view of the fractured bolt.*

failed. The blade had struck the side of the vertical stabilizer (pylon). Inspection of the failed bolt indicated that it had failed due to fatigue. There were indications that the bolt had been loose at some time in the past and further investigation of the damaged components indicated reverse bending damage, as would be expected in a loose bolt.

As a result of this occurrence, the operator changed their maintenance practices to ensure that the bolts are replaced at each tail rotor installation. Bolts will also be replaced if they are subsequently found to be loose during service.

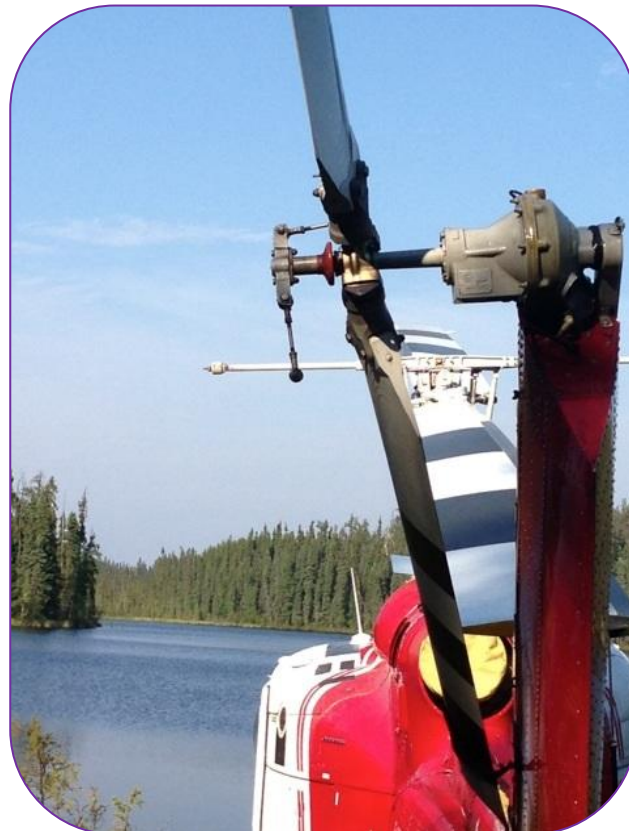
On the 2013 flight, there were a total of five people on board. The tail rotor had been installed about 45 hr prior to the occurrence. As it had been the case in the 2003 occurrence, the aircraft maintenance engineer (AME) used the existing attachment hardware. Examination of the hardware by the TSB indicated that the bolt had likely been operated, at some time previous, in a loose condition and probably already had a fatigue crack when the new tail rotor was installed. There was a step worn in both bolts (very small 0.002 in.) and there

*Photo 4: Detached pitch link—2013 occurrence*

were signs that the bolts had been rotating. The attaching washers also had recessed rings worn into them from the bolt heads and the bearing shoulders. These were the indications mentioned in the summary above.

Given the repeated occurrences and the potential serious outcome of such an event, we felt that it was important to highlight this issue. These events demonstrate the value of replacing attachment hardware at each component installation as well as replacing hardware if looseness is ever noted. △

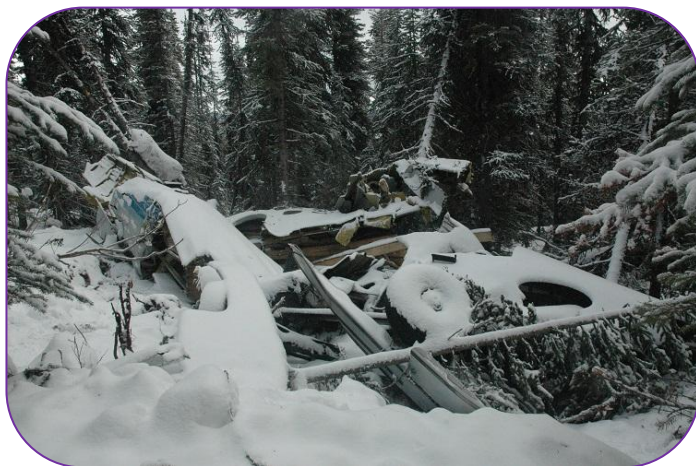
*Main wreckage site where most of the fuselage and cargo were found.*

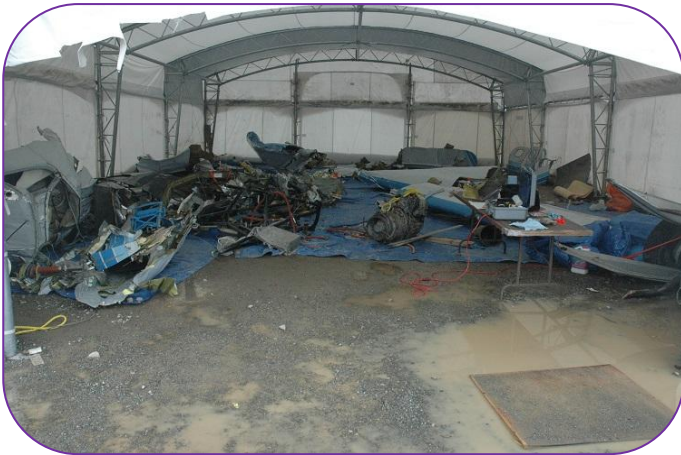
*Temporary hangar where the wreckage was recovered for initial examination, before it was moved to the TSB lab in Ottawa.*

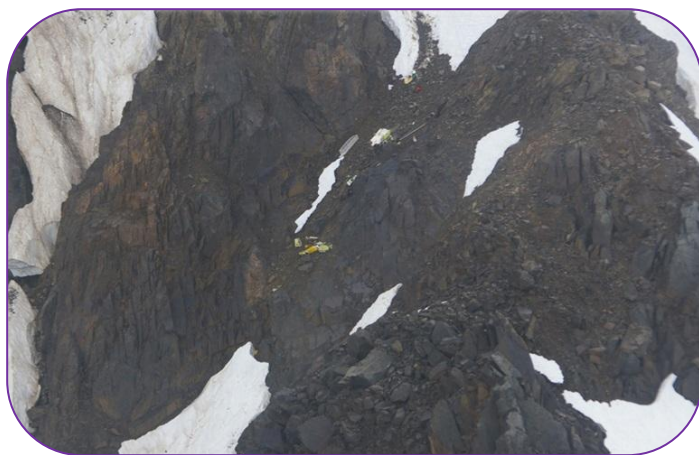
*Strewn wreckage on the steep mountain side*

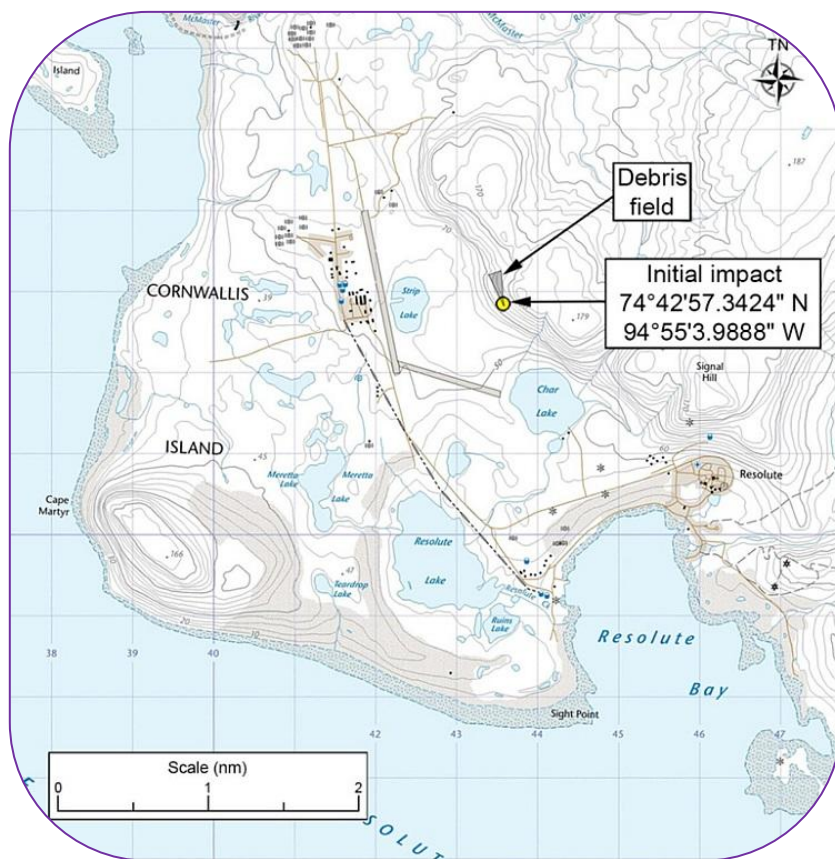
*Accident site*

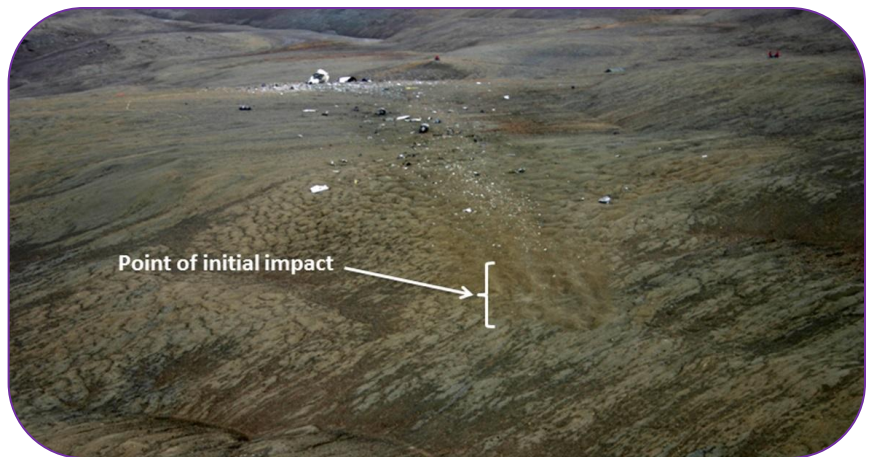
*Accident site looking north*

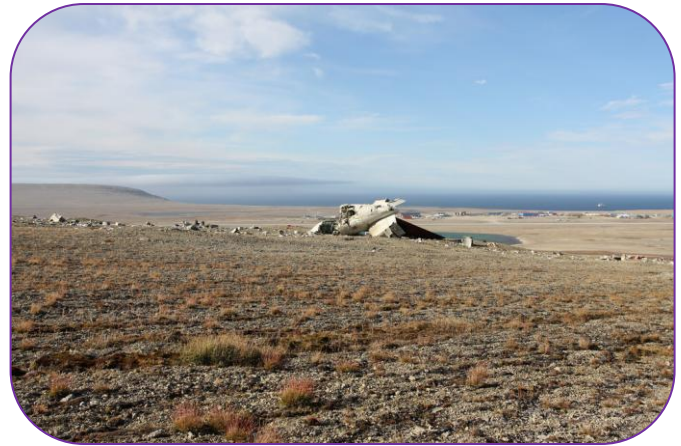
*Accident site at the surface*

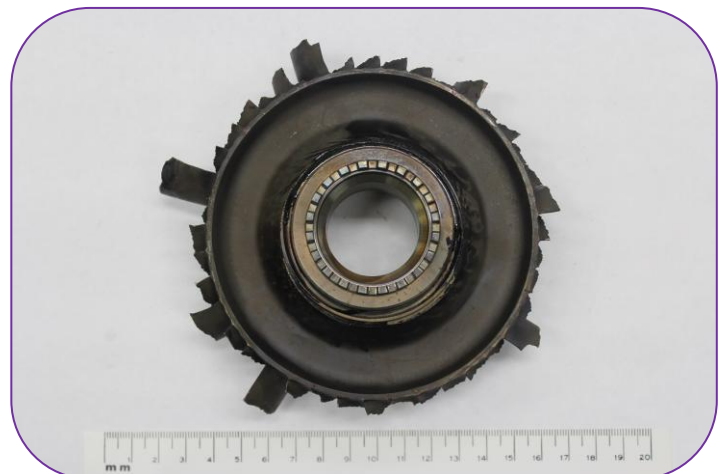
*Occurrence third-stage power turbine wheel*

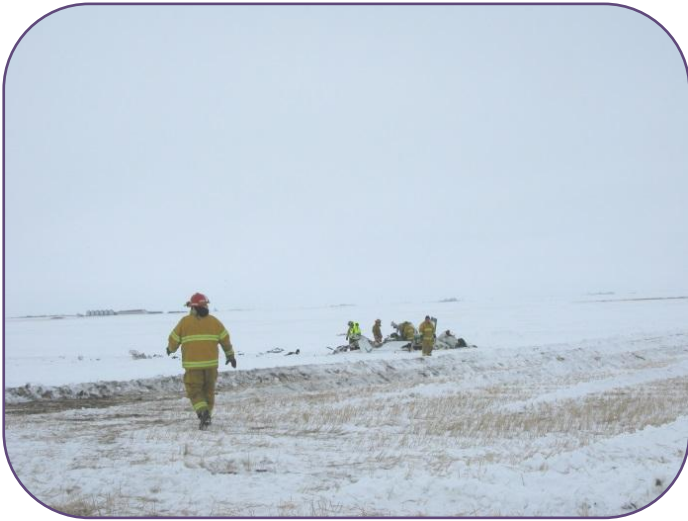
*Emergency personnel and TSB investigators at the crash site near Waskada, Manitoba. This photo of the accident site illustrates how the area was conducive to whiteout.*

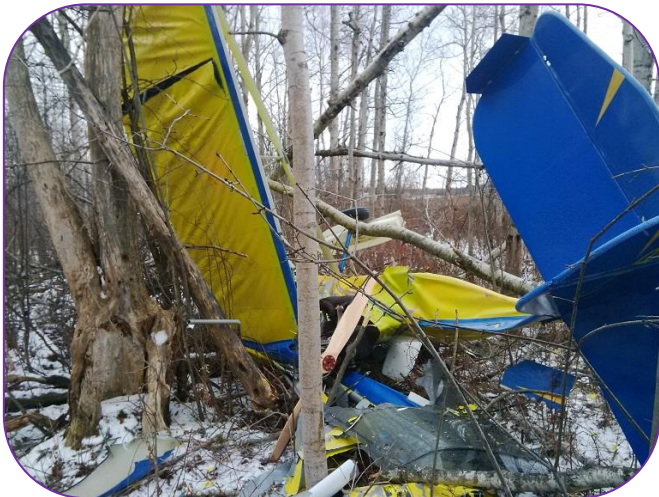
*TSB File A13O0223*

— On November 29, 2013, a **Quad City Challenger II ultralight** was completing circuits at Baldwin Airport (CPB9), Ont. During takeoff from Runway 01, while climbing through 200 ft to 300 ft, the aircraft suffered a power loss (Rotax 503) and the pilot attempted to turn right to return to the field. During this turn, the aircraft stalled and impacted the ground in a wooded area 200 m west of the departure end of the runway. The aircraft was destroyed on impact; however, the pilot, who was wearing a helmet and four-point seatbelt, suffered only minor injuries. *TSB File A13O0223*.

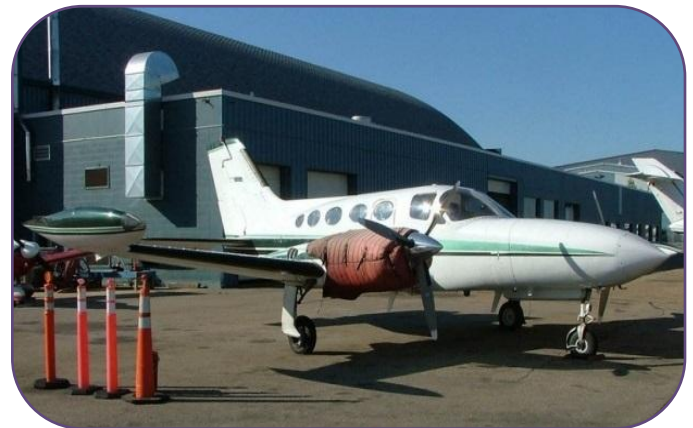
— On December 14, 2013, a **Cessna 421B**, with two persons on board, was flying IFR en route from Abbotsford, B.C., to Tofino, B.C. The aircraft was lost on ATC radar in the vicinity of Tofino. A search commenced and the aircraft wreckage was located the following morning on Vargas Island, about 11 NM northwest of Tofino Airport. Both persons on board are assumed fatally injured as the aircraft was partially buried in a marsh, and the bodies were not visible. There was no fire. *TSB File A13P0305*.

*The Cessna 421B that crashed on Vargas Island, B.C.  
(photo: Ray Barber / Airport-data.com)*

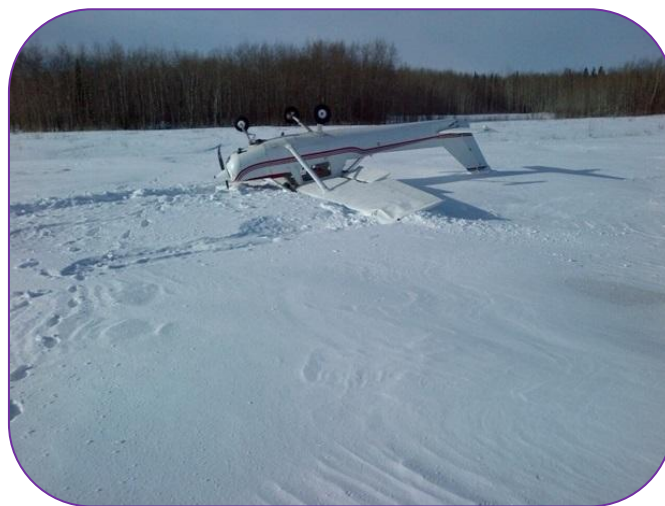
*TSB File A14C0018*

— On January 25, 2014, a **Cessna 152** was on a flight from St. Andrews, Man., to Lac du Bonnet Regional Airport (CYAX), Man. The pilot conducted a low pass to inspect the runway before landing. On touchdown, the aircraft encountered snow up to 12 in. deep. The aircraft veered left to the edge of the runway, struck a snow drift and overturned. The pilot and passenger exited without injuries. The aircraft sustained substantial damage to its wings, tail and propeller. *TSB File A14C0018.*
