TP 185E  
Issue 4/2018

# AVIATION SAFETY LETTER

*TSB Final Reports*

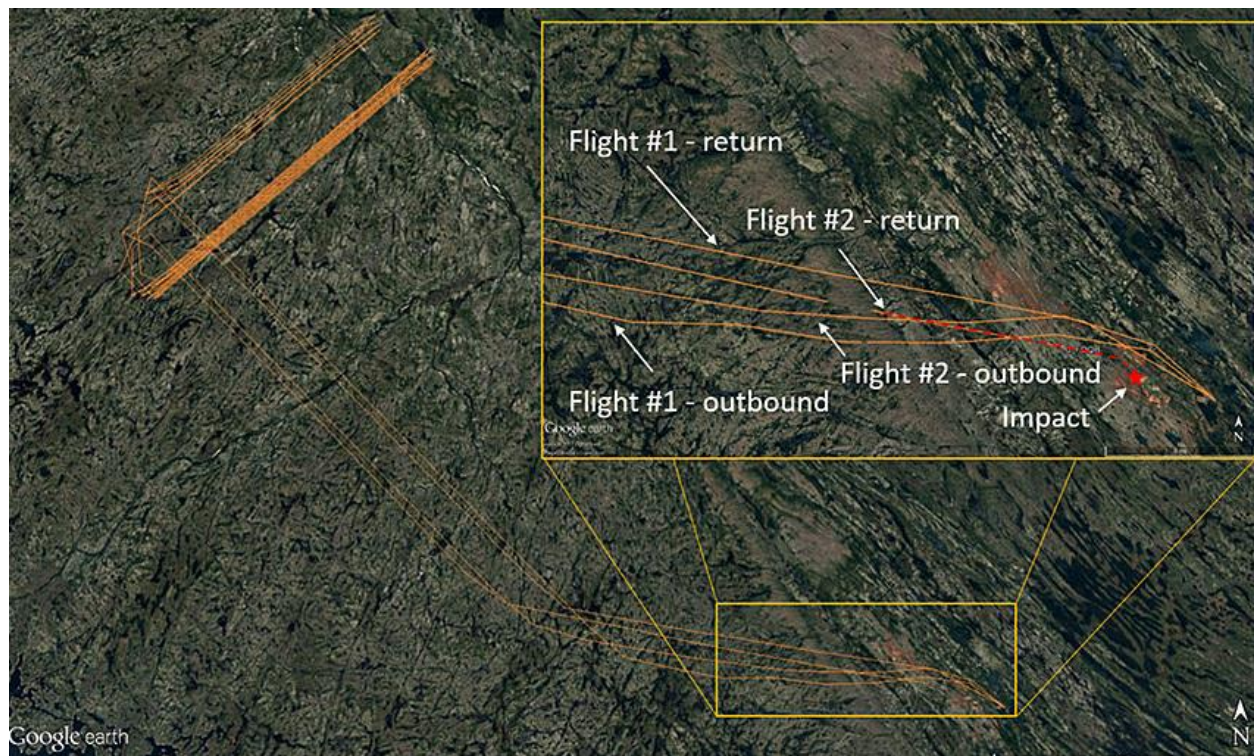
At 17:56, while the aircraft was flying over railway tracks, it struck the conductor cables of a power transmission line and crashed on top of a mine tailings deposit located approximately 3.5 NM northwest of CYKL (Figure 1). There was no fire, but the aircraft was completely destroyed by the impact forces, and both pilots were fatally injured.

Figure 1. The 2 flights conducted by the aircraft in cause on the day of the accident, with detail showing the very-low-altitude flight segments (Source: Google Earth, with TSB annotations)

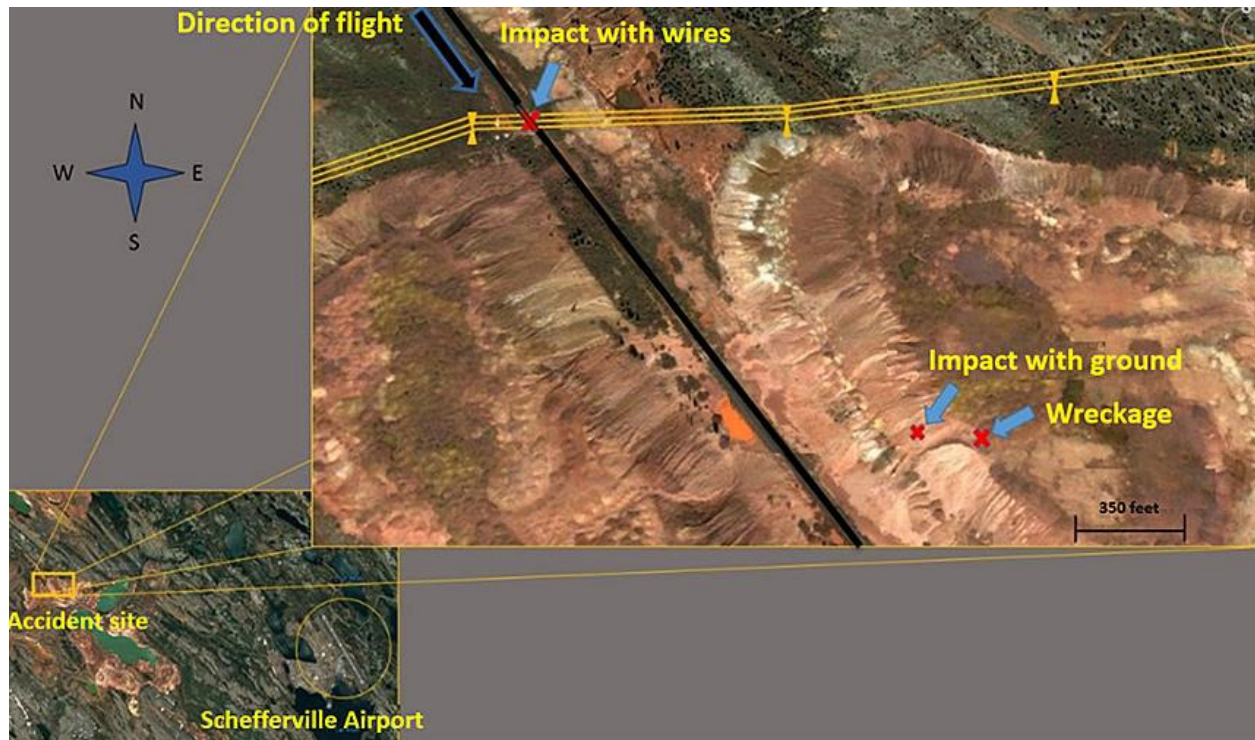
Figure 2. Accident site details

The accident occurred at the mouth of a small valley created artificially by a former mine tailings deposit located on either side of a railway track (Figure 2). A power transmission line spanned across the tracks just before the mouth of the valley.

After striking the wires, the aircraft remained airborne and deviated to the left before colliding with the ground, close to the top of the ascending slope of the mine tailings deposit, on the east side, approximately 1400 ft southeast of the impact with the power transmission line.

The 3 cables were severed, with 2 remaining hooked to the aircraft's left engine until fully extended, when they were again severed at their anchor point on the aircraft.

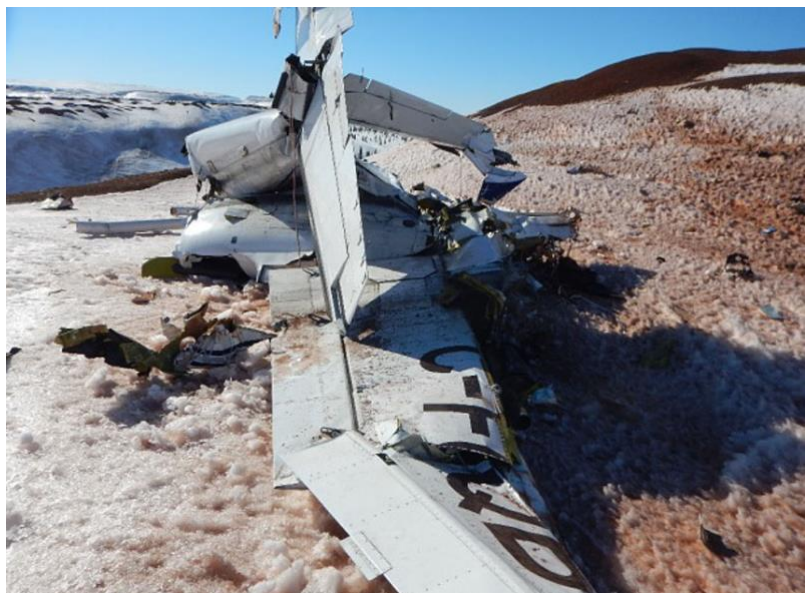
Figure 3. Wreckage

The aircraft wreckage was found at the top of the plateau, about 134 ft east of the initial point of impact with the ground (Figure 3). The left engine was separated from the wreckage (Figure 4) and was found slightly farther away, with the propeller. Sections of the conductor cables were wrapped around the left engine propeller drive shaft.

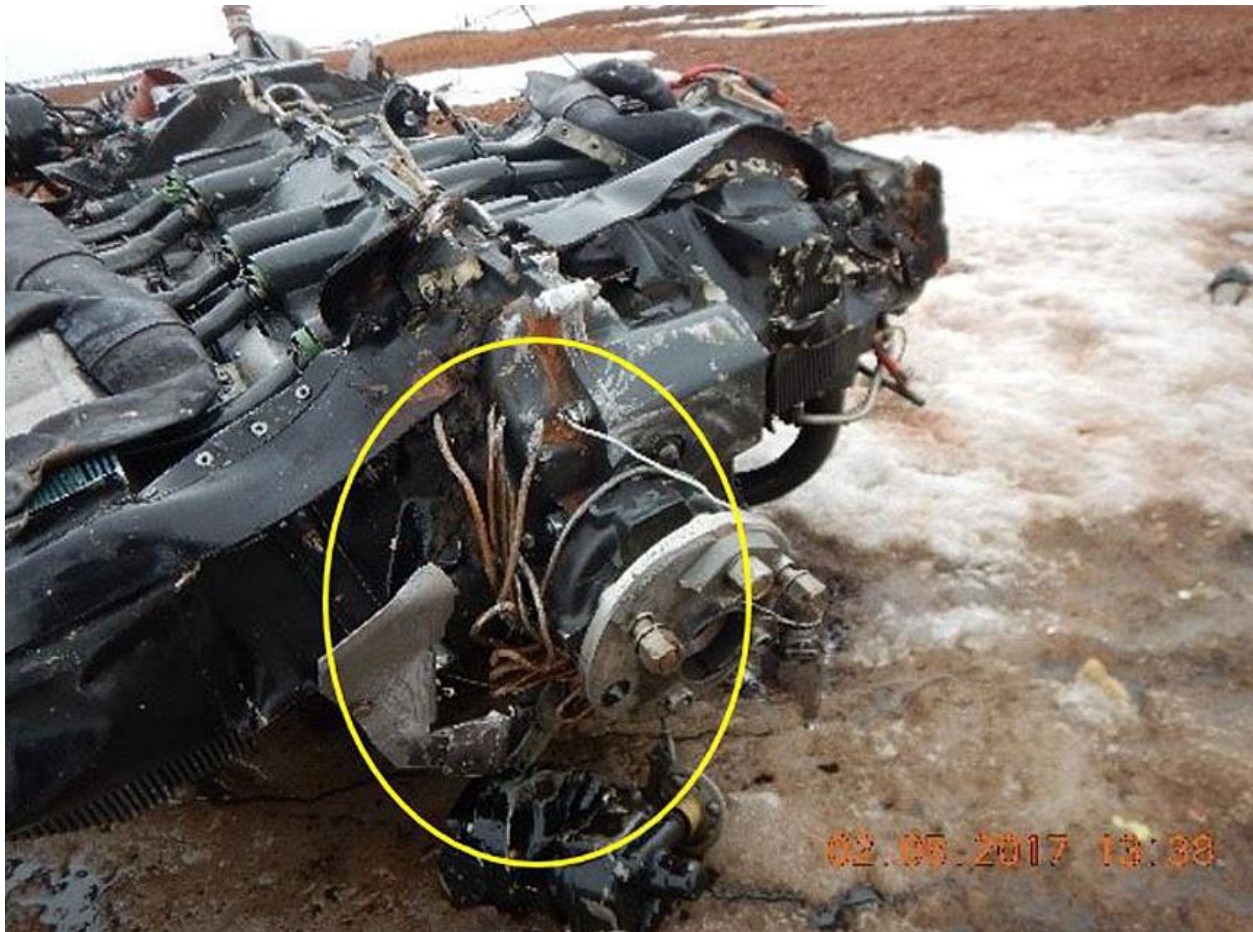
*Figure 4. Left engine: the circle shows the severed pieces of cable wrapped around the propeller drive shaft*

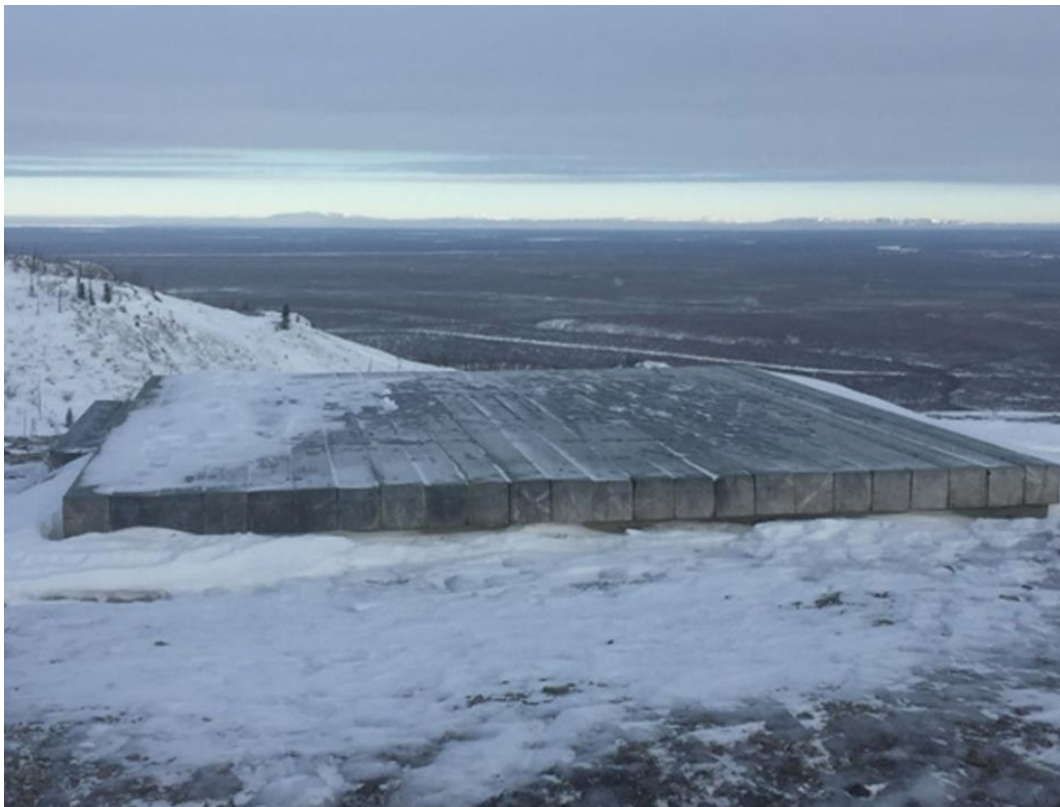
*Figure 1. Helipad on Bear Rock*

At 09:58, the helicopter landed on a helipad near the telecommunications tower and was shut down. The helipad, measuring 16 feet (ft) by 16 ft, is made of treated timber. At the time of the occurrence, the helipad was mostly bare wood; however, there were several patches of ice (Figure 1).

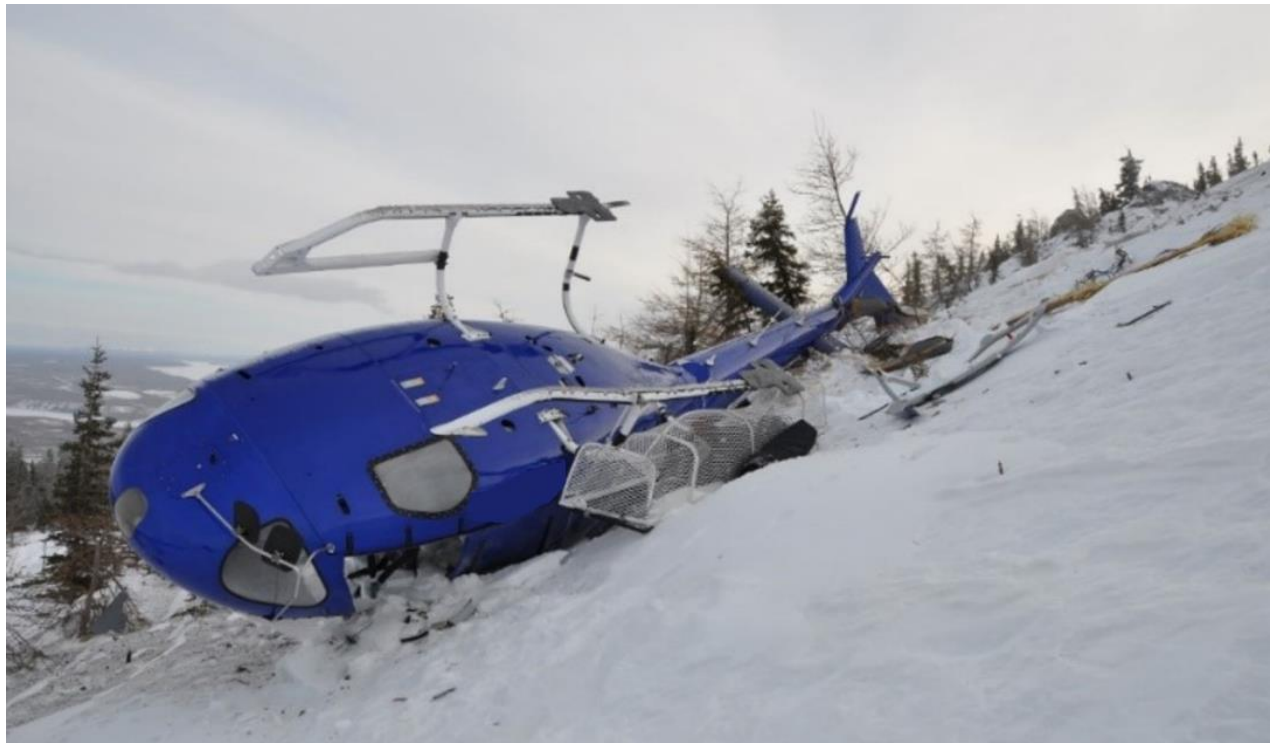
*Figure 2. Front side of the occurrence helicopter, looking to the east*

During the impact sequence in this occurrence, the main rotor head was significantly damaged. Two of the 3 frequency adapters were recovered from the accident site. Examination of the rotor head components did not identify any indications of pre-impact failure.

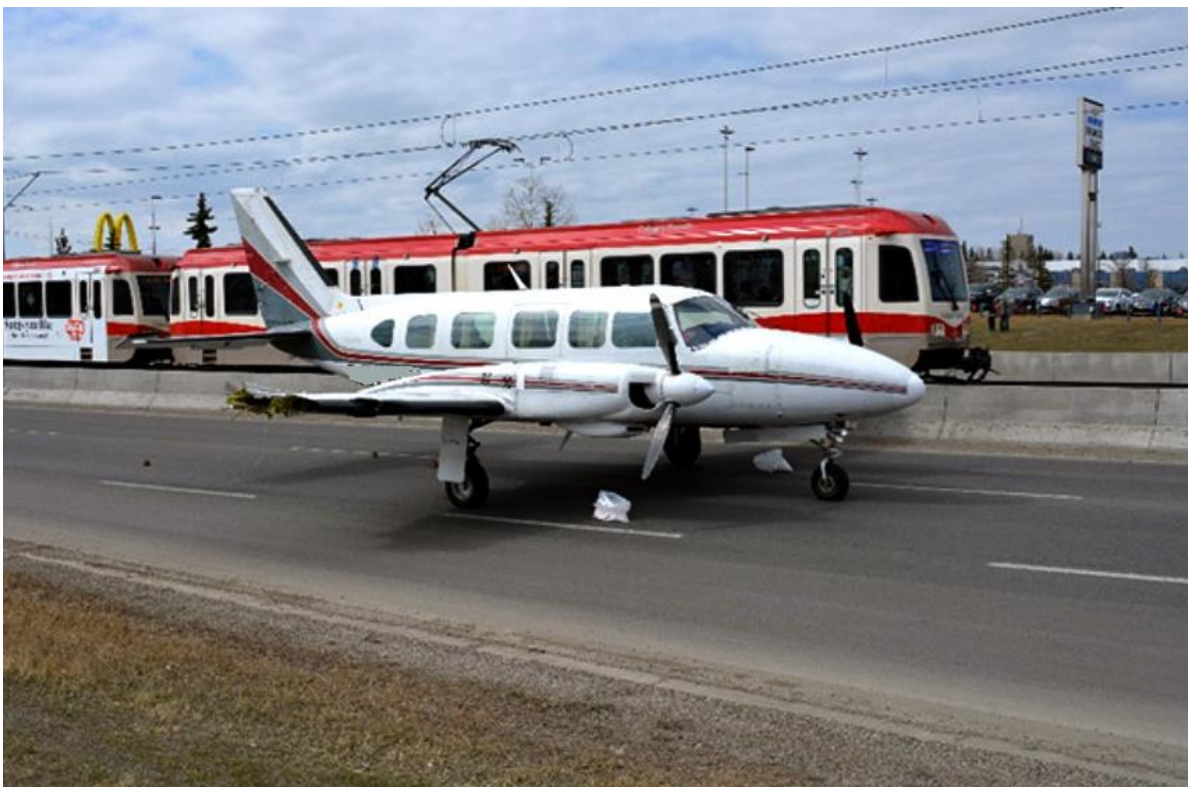
The aircraft touched down in the northbound lanes of 36 Street N.E., just north of the intersection with Marlborough Drive N.E. Shortly after the aircraft touched down, its right wing contacted a light standard on the right side of the road, shearing off the outer 4 ft of the wing. The aircraft continued north, through the intersection with Marbank Drive N.E., and came to a stop just south of the on-ramp for eastbound 16 Avenue N.E., which is part of the Trans-Canada Highway (Figure 1).

*Figure 1. The occurrence aircraft after coming to a stop on 36 Street N.E., Calgary, Alta.*
