Transport  
Canada

TP 185E  
Issue 3/2006

# AVIATION SAFETY LETTER

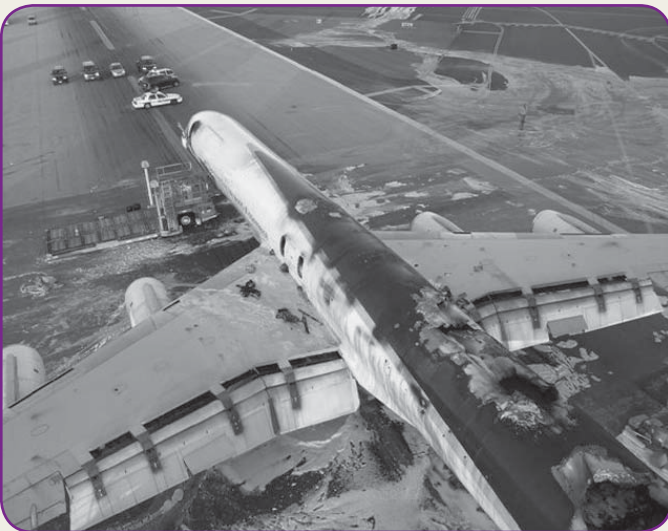
This courier flight made an emergency landing in Philadelphia, PA, after the crew detected smoke in the cockpit. The SMOKE/FIRE warning light illuminated three minutes prior to landing, and the crew asked the tower controller to confirm the presence of fire trucks, which the controller did. Upon landing, the airplane was immediately engulfed in fire and the three members of the crew evacuated the airplane via the cockpit window and a door slide. The crew was not injured; however, the airplane was destroyed. The crew did a brilliant, by-the-book job of saving their own lives, while the professional response from ATC and the firefighting units also contributed to their timely and successful egress. Two known pieces of hazardous materials (HAZMAT) were reportedly on board: amyl methyl ketone and tire repair kits. △

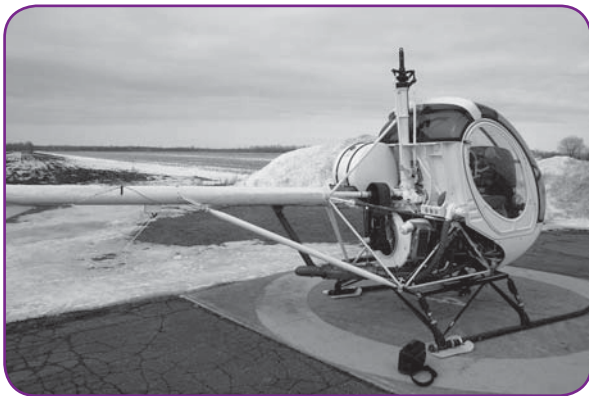
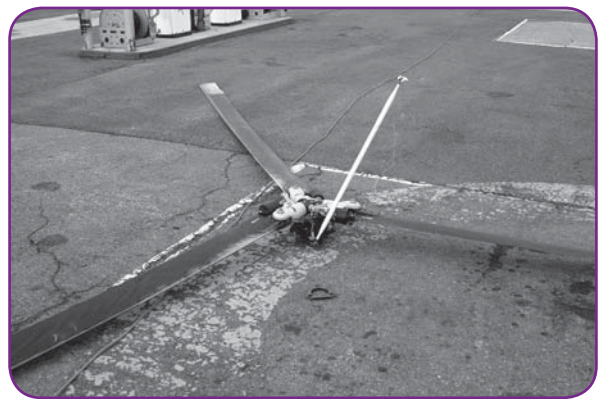
On March 8, 2004, a Schweizer 269C-1 helicopter with one pilot on board, was undergoing ground tests following a 100-hr inspection and replacement of the main transmission gearbox. After the second test to check for leaks and to measure tail rotor vibration, engine rpm was reduced. At this time, the pilot and ground engineer heard a noise. The noise was heard again on the third test. Engine rpm was reduced, but this time the main transmission gearbox stopped turning suddenly and caused the main rotor to separate from its shaft. The main rotor rose to an altitude of approximately 150 ft above ground level (AGL) and came to rest on the apron of the heliport, about 100 ft from the helicopter. The helicopter remained in place and there were no injuries. The accident occurred at 11:45 Eastern Standard Time (EST).

1. The input quill bearing housing was not positioned in accordance with the procedures described by the manufacturer; therefore, the flow of oil was obstructed, causing the catastrophic failure of the input quill bearings.
2. Independent inspection did not detect the incorrect reassembly of the main transmission gearbox.

1. There are no mechanical means to prevent an installation error when installing the input quill bearing housing.
2. The force required to shear the main rotor shaft is higher than the force required to shear the six rotor head attachment bolts. As a result, the rotor could separate from the shaft in the event of a sudden stoppage of the transmission, which constitutes a hazard for helicopter occupants and people on the ground.

*Main rotor lies on the ground, after it separated from the aircraft*

At the completion of the main transmission overhauls, at sudden stoppage inspections, or in any other situations in which the retainer has to be removed, the overhaul company will paint a red witness line on the retainer and on the transmission housing to assure alignment of oil ports. Also, they will run the transmission for 15 min to check that there is oil flow in the transmission, and to check for oil leaks at the seal and split line. These changes will be put into their worksheets.

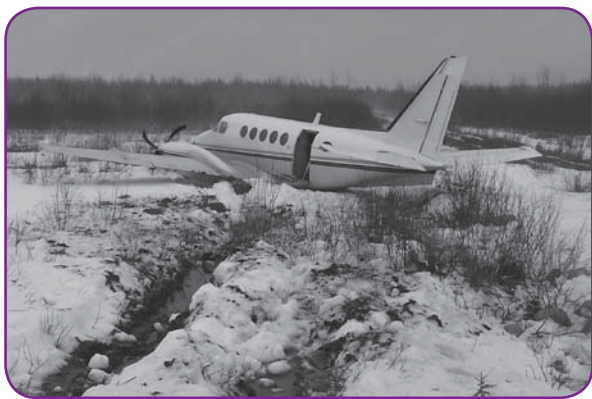
On April 19, 2004, a Beechcraft A100 was on a chartered IFR flight from Québec/Jean Lesage International Airport, Que., to Chibougamau/Chapais Airport, Que., with two pilots and three passengers on board. The co-pilot was at the controls and was flying a non-precision approach for Runway 05. The pilot-in-command took the controls less than 1 mi. from the runway threshold and saw the runway when they were over the threshold. At approximately 10:18 Eastern Daylight Time (EDT), the wheels touched down approximately 1 500 ft from the end of Runway 05. The pilot-in-command realized that the remaining landing distance was insufficient. He told the co-pilot to retract the flaps, and applied full power, but did not reveal his intentions. The co-pilot cut power, deployed the thrust reversers, and applied full braking. The aircraft continued rolling through the runway end, sank into the gravel and snow, and stopped abruptly about 500 ft past the runway end. The aircraft was severely damaged. None of the occupants was injured.

1. The aircraft was positioned over the runway threshold at an altitude that did not allow a landing at the beginning of the runway, and this, combined with a tailwind component and the wet runway surface, resulted in a runway excursion.
2. Failure to follow standard operating procedures (SOP) and a lack of crew coordination contributed to confusion on landing, which prevented the crew from aborting the landing and executing a missed approach.
3. The pilot-in-command held several management positions within the company and controlled the pilot hiring and dismissal policies. This situation, combined with the level of experience of the co-pilot compared with that of the pilot-in-command, had an impact on crew cohesiveness.

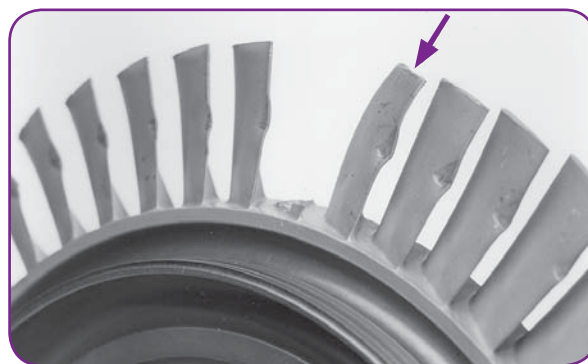
Arrow pointing to blade failure caused by thermally-induced fatigue cracking

1. Thermally-induced fatigue cracking initiated radially inward in a low-cycle mode in the blade platform fillet area, then progressed normal to the blade axis in a high-cycle mode, eventually resulting in a blade failure due to overstress rupture when the remaining area could no longer support the applied loads.

1. Hot starting events and/or power transients are not recorded in this type of helicopter and may not be recorded accurately by an operator even if detected. Turbine wheel failures may occur when hot starts and power transients are undetected, or if their effects go unchecked.
2. The first-stage turbine wheel revealed many type A, and approximately four type B, cracks in the blade rim, and cracks in the fillet radius of blades can lead to turbine failures. There is no prescribed scheduled inspection to detect these cracks, but a turbine special inspection is

recommended when turbine outlet temperature limits are exceeded. No cracks in the blades are allowed.

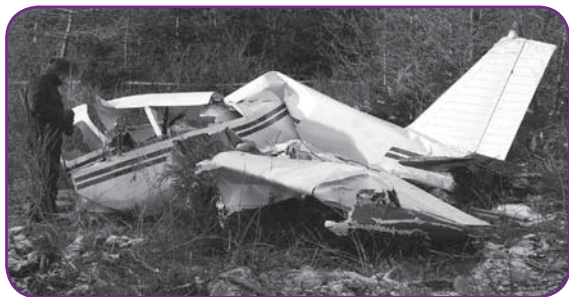
*TSB aircraft accident investigator  
Allan Chaulk examines the wreckage*

1. The aircraft was flying in conditions conducive to serious carburetor icing at any engine power setting. It is likely that carburetor ice formed and restricted the engine power available to the point where the aircraft would not maintain level flight.

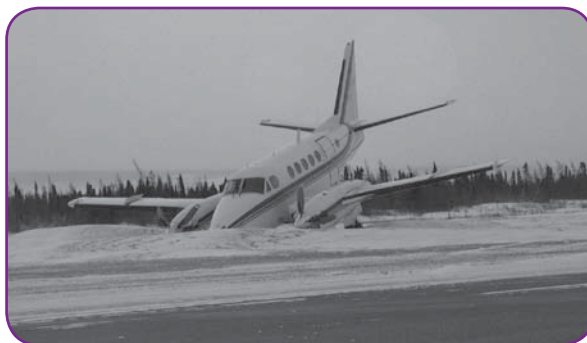
On December 24, 2004, a Beech King Air BE-A100 departed Puvirnituq, Que., under IFR for a scheduled flight to Kuujuaq, Que. There were two crew members, four passengers, and cargo on board. Strong crosswinds and slippery runway surface conditions had been reported by the Kuujuaq flight service station (FSS) personnel. The crew conducted an ILS approach to Runway 07 in IMC and touched down at 19:43 EST. Immediately after landing, the aircraft started skidding to the right and departed the landing surface, coming to a rest 1 600 ft from the threshold, and 40 ft to the right of the runway. The aircraft was substantially damaged, but none of the crew or passengers was injured.

1. The crew did not assimilate the information regarding wind and runway conditions, and continued an approach for which there was no viable landing option.
2. The first officer did not anticipate a landing on Runway 07, which did not allow the crew to properly discuss the risk of landing on a slippery runway in strong crosswind conditions.
3. The flight crew did not make use of crosswind charts during flight planning or when preparing to land at Kuujuaq.
4. Company SOPs do not provide specific guidance with respect to maximum crosswind or minimum Canadian Runway Friction Index (CRFI) values.

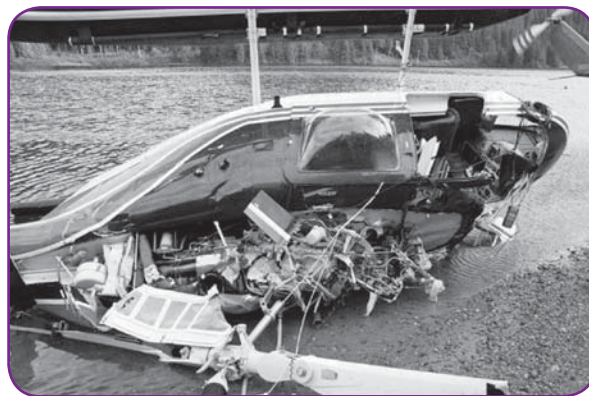
sampling operations for Environment Canada. It departed Chilliwack, B.C., with one pilot and two Environment Canada employees on board. Their mission involved landing on lakes north of the Vancouver Lower Mainland area to collect water samples. Following landings on eight different lakes, where the winds were light and variable, they attempted to land on Devils Lake, where the wind was calm. The water was quite glassy and was shaded from the sun by hills. The pilot made a shallow approach from the south to the middle of the lake, with reference to the shoreline 200 to 400 m away and some small ripples on the water. Before the pilot anticipated touching down, the helicopter struck the surface of the lake and flipped onto its back. It remained afloat supported by the floats, but the cabin was submerged. The passenger from the back seat and the pilot were able to exit the wreckage, but the passenger seated in the left front seat was unconscious. The passenger who had escaped the wreckage rescued the front-seat passenger but she died about six days later from injuries received in the accident. The helicopter sustained substantial damage. The accident occurred at about 13:00 PDT.

1. Glassy water conditions impaired the pilot's ability to judge his height above the lake, and during the landing, the helicopter's floats contacted the water before the pilot expected them to, dug in, and the helicopter flipped over.
2. One of the helicopter's main-rotor blades broke on contact with the water and penetrated the front of the helicopter. Wreckage debris struck the pilot and the front-seat passenger on their heads.

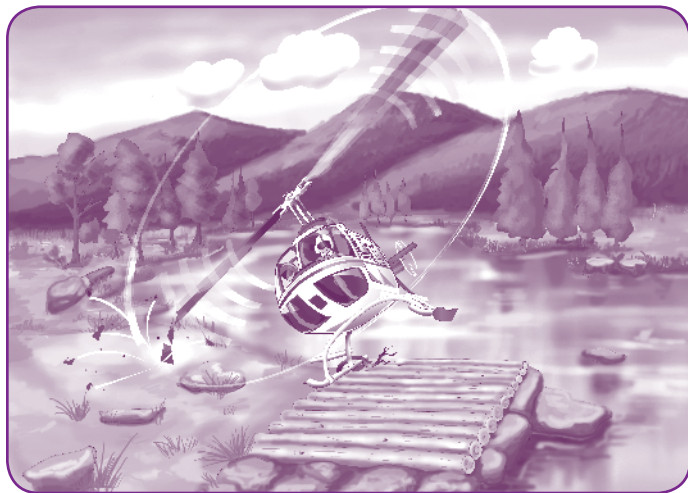
—On November 9, 2005, a **Bell 206B helicopter** was transporting two passengers from Island Lake, Ont., to a fishing camp situated 50 NM east of Island Lake, on East Lake, Ont. Upon touching down on a log-constructed landing pad, the pilot applied collective to reposition the helicopter on the pad. The right bear paw on the high-skid landing gear caught a root or stump near the pad, and the helicopter rolled over onto its right side. The pilot and passengers were wearing shoulder restraints, which minimized their injuries; one passenger received a minor cut to the head. The pilot used an on-board satellite phone to call for assistance. *TSB File A05C0204.*

*Artist's impression of the rollover as it happened*

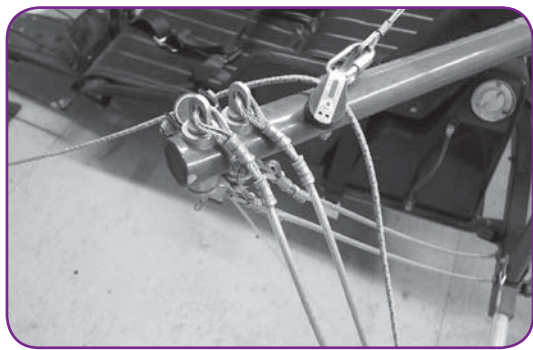
Figure 1. Close-up of left outrigger and eye bolts, with the riser cables in the correct pre-flight position

The pilot encountered control difficulties immediately after lift-off, and at that time, it was observed that a stainless steel riser cable was looped around the left outrigger arm. The pilot and passenger attempted to slide the riser cable over the end of the outrigger to remove the loop; however, the cable was taut and could not be repositioned due to the air loads on the canopy. The left turn progressed to a tight left spiral, and the parachute collapsed prior to the cart impacting the ground.

The powered parachute utilized aircraft-grade eye bolts to attach the stainless steel riser cables to the outboard ends of the outrigger arms. The nicopress thimble-eyes on the riser cables allowed the riser cables to move freely in the eye bolts. The steering lines were routed through hardware mounted inboard of the eye bolts (see Figure 1). Newer versions of the aircraft utilize a slightly more rigid system of shrouded nylon riser straps in place of eye bolts and cables (see Figure 2).

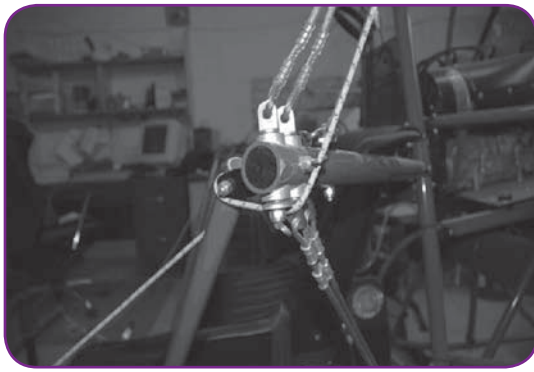
With either system, a pilot must verify that the steering lines, risers, and suspension lines are correctly positioned above the outrigger arms on the pre-flight check, by "walking the lines" with the parachute canopy and suspension lines laid out behind the cart. Standard practice also requires that the pilot apply partial power to get the cart rolling slowly at the beginning of the take-off run, and then conduct a "shoulder check" to the left and right as the parachute rises over the cart, to visually confirm that the steering lines and risers are correctly positioned above the outrigger arms. If a riser or steering line wraps around an outrigger, the wrap will effectively shorten the riser or steering line, which precludes proper chute inflation (see Figures 3 and 4).

Figure 3. Photo of the steering line wrapped around the outrigger, with the riser cables upright in the normal in-flight position

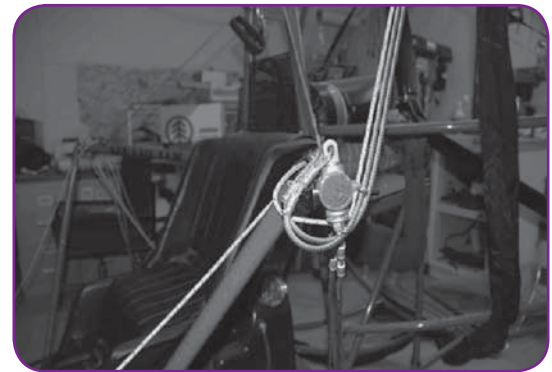
Figure 4. Photo of riser cables and steering line wrapped around the outrigger arm

The *Operator's Manual* emphasizes that during takeoff, the pilot is to perform a visual scan to ensure that the chute is overhead and centered, that the chute is pressurized, that the end cells on both sides are open, that the risers and lines show no tangles, and that the steering lines are free of tangles and properly positioned. It also contains a warning that a chute that is not fully and properly inflated before takeoff may result in total loss of control of the aircraft and serious injury or death. A pilot must abort the takeoff immediately if the chute does not inflate normally.

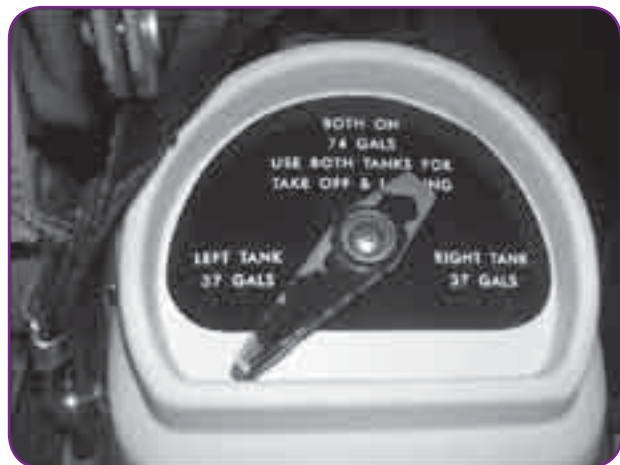
The valve is described in the pilot operating handbook (POH) as a “three-position selector valve labelled LEFT TANK, RIGHT TANK, and BOTH ON.” When not installed, the valve can be rotated to a fourth position, OFF, that is 180° opposite the BOTH position. The valve has detents that have the same tactile feel in all four positions. However, when installed, it is constrained from being selected to the OFF position by a plastic ridge around the fuel tank selector cover, as shown in Figure 1. This plastic ridge can be stepped on by passengers and damaged. If this happens, the fuel tank selector valve can be accidentally rotated to the OFF position.

Figure 1. Fuel tank selector cover prevents selection of the undocumented OFF position

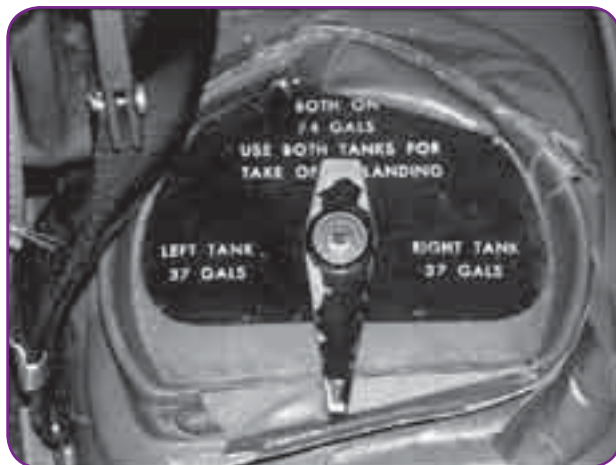
Figure 2. Damaged fuel tank selector cover—fuel selector in undocumented OFF position

As seen in Figure 2, the ridge on the plastic cover was damaged, allowing the selector valve to be rotated to the OFF position. The valve was also partially obscured by the water rudder handle, so the pilot relied on feel to determine the switch position, and the incorrect position of the valve was undetected. The fuel in the accumulator tank (approximately ½ gal.) was sufficient to allow the pilot to start the engine, taxi, carry out run-up and before-takeoff checks, and take off, before it was exhausted, shortly after the aircraft became airborne.
