Transport  
Canada

TP 185E  
Issue 4/2009

# AVIATION SAFETY LETTER

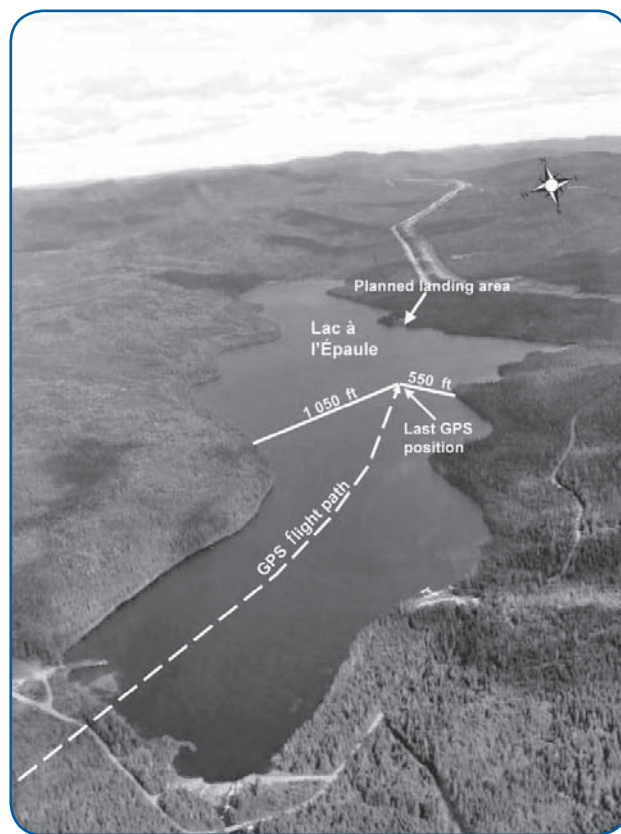
When the pilot selected demist hot air to clear the windshield, the warm air from the ceiling ventilation ducting was instantly cooled when it hit the relatively cooler windshield. This rapid cooling caused the air to condense, and fogged the windshield and front side windows. The immediate fogging of the windshield and front side windows, combined with the heavy precipitation, restricted the pilot's ability to maintain outside visual references. He did not have time to open

the bad weather window, which could have given him some outside visibility. Without any outside visual cues, the pilot did not perceive that the helicopter was descending from 100 ft above ground level (AGL); the helicopter struck the surface of the water at low airspeed.

*Map showing the trajectory and impact point of the helicopter, which was proceeding towards a cottage at the north end of Lac à l'Épaulé.*

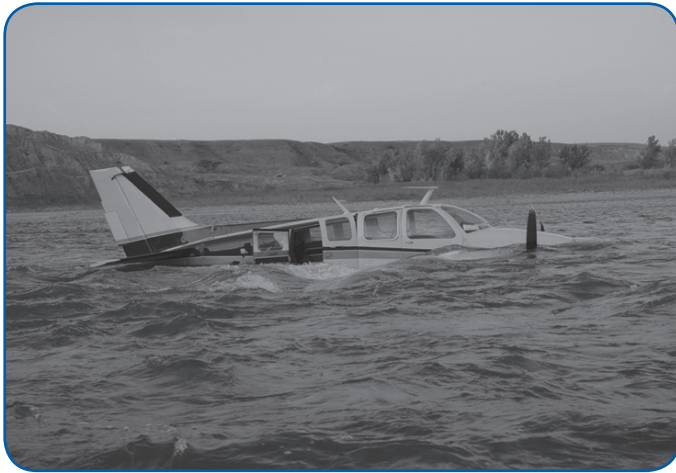
*Photo 1: This Beech 58 Baron forced landed in South Saskatchewan River after the right engine lost power.*

The right engine was removed and successfully run on a test stand. Subsequent visual inspection and flow check of the related fuel injection components, and detailed examination of the airframe fuel system, did not reveal any system abnormalities that would have precluded normal function. While the reason for the loss of

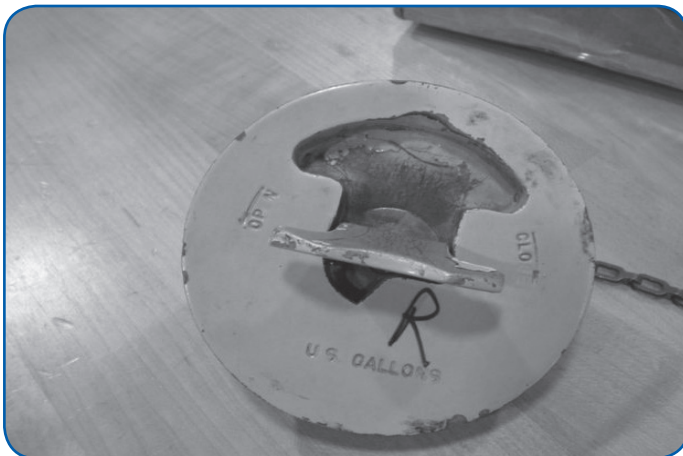
One potential pathway for free water, in the form of rain or wash water, to enter aircraft fuel tanks is through fuel caps that do not seal properly. The aircraft was fitted with two standard, flush-mounted fuel caps manufactured by Shaw Aero Devices<sup>1</sup>. (See Photos 2 and 3.) This type of fuel cap is installed in numerous models of small aircraft. The cap seals consist of two O-rings, one around the outer circumference of the cap and one on the shaft of the locking mechanism axle. Water leakage was detected post-accident during in situ testing of the fuel caps, with the fuel caps secured in the filler openings. The handle bearing plates also showed excessive wear and the caps had parts missing.

*Photo 2: Top view of flush-mounted fuel cap*

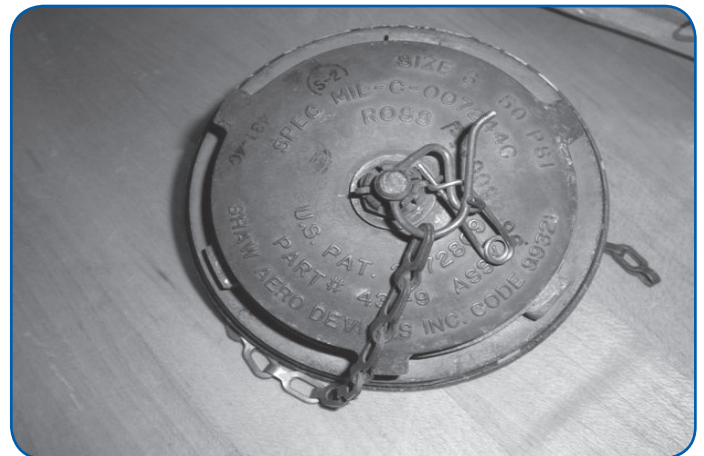
*Photo 3: Bottom view of flush-mounted fuel cap*

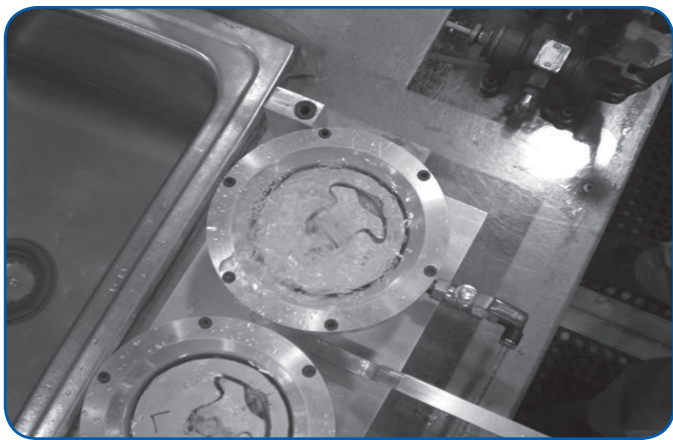
The fuel caps were forwarded to the manufacturer, where they were tested in accordance with Shaw Aero Devices standard acceptance test procedures for fluid filler caps and adapters. The procedure required the fuel caps to be mounted in a test fixture and 5 to 25 psi pressure to be applied to the underside. No leakage is permitted. At 0.5 psi, both caps leaked past the axle and handle assemblies. (See Photo 4.) The caps were disassembled and inspected. The O-rings on the axle shafts in both

Photo 4: Fuel caps on test pot—note air bubbles above cap in middle of picture that indicate leakage

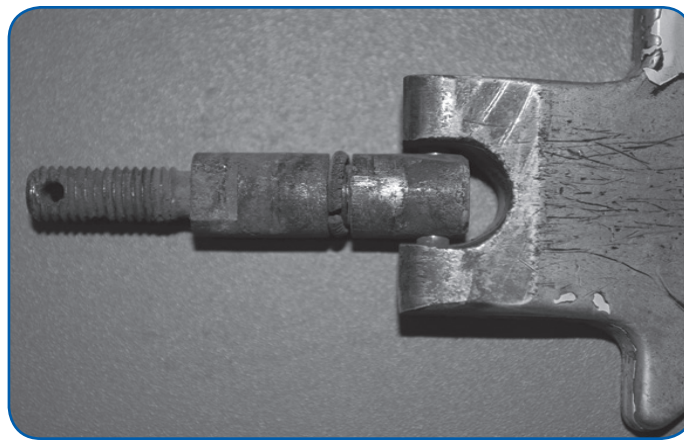
caps were cracked and broken, and both axle shafts were corroded sufficiently to indicate long-term exposure to moisture. (See Photo 5.)

Photo 5: Note deteriorated O-ring and corrosion on axle shaft

maintenance instructions. AC 43.13-1B simply states that fuel cap O-rings are to be inspected to determine that they are in good condition. Furthermore, Shaw Aero Devices considers the fuel caps to be a “return to vendor” item if repair, including O-ring replacement, or overhaul is required.

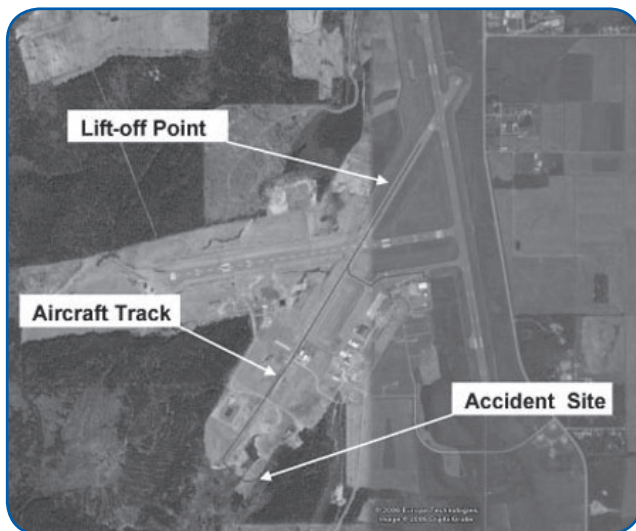
On May 31, 2006, the pilot of a Cessna 185B departed Prince George, B.C., from Runway 19 on a flight to Scoop Lake, B.C. The aircraft flew on the runway heading until it was about 2 400 ft beyond the departure end of the runway, where it abruptly pitched up, climbed steeply, turned left, and rapidly descended into trees about 600 ft left of the runway's extended centreline. The aircraft was airborne for less than 47 s and reached a maximum height of about 270 ft above ground level (AGL). The aircraft was destroyed, and the pilot, who was the sole occupant, was seriously injured. There was no fire.

*Departure path from Prince George Airport*

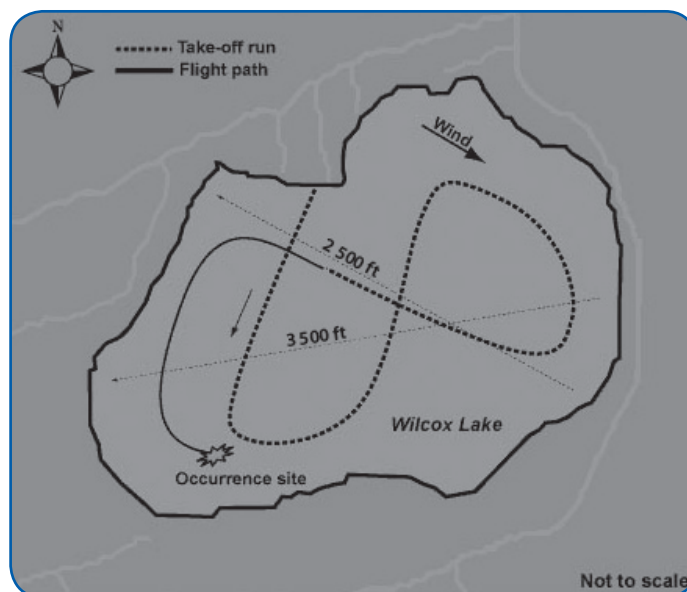
*Wilcox Lake takeoff diagram*

The figure-eight manoeuvre that was used during the takeoff entailed changing direction twice and, because of the speed of the aircraft, a large radius turn could be expected. The aircraft was approximately 200 ft from the east-southeast shoreline before turning to a northwest direction for the final take-off run. There is an inherent risk related with changing directions while step taxiing, depending on the associated wind and wave conditions. During a step taxi turn from a tailwind to a headwind, the wind acts on the underside of the inboard wing, causing it to rise. This, combined with upward movement caused by wave action and pressure from centrifugal forces acting on the aircraft during the turn, can lead to the aircraft capsizing.

The distance available for takeoff into wind, in a northwest direction, was insufficient. While there was enough distance to get airborne, the aircraft would not have been able to climb safely to an obstacle clearance altitude of 50 ft. The pilot elected to use a step-taxi turn in an attempt to shorten the take-off run. However, this had a negligible effect because the turn radius of the aircraft was increased during the final turn, thereby shortening the into-wind take-off distance available. After liftoff, the slow speed of the aircraft did not provide much margin above the stall speed for manoeuvring. As the aircraft banked to avoid obstacles, the stall speed increased, and the aircraft stalled.

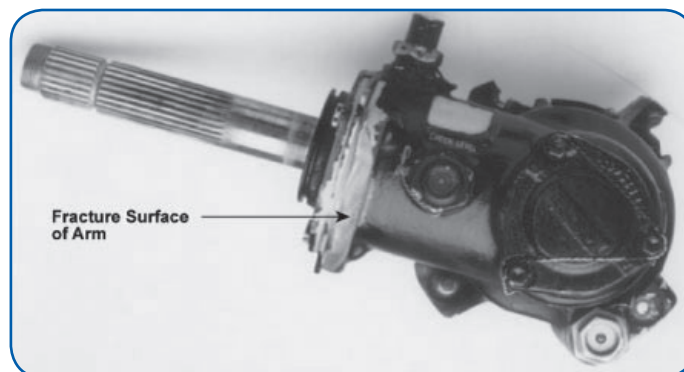
*Tail rotor gearbox showing fracture of bell crank support arm*

Analysis of the fracture revealed a pre-crack/fatigue crack extending across approximately 75 percent of the entire cross section of the bell crank support horn. The fractured horn did not contribute to the accident.

On February 20, 2007, the TSB issued Safety Information Letter A06C0131-D1-L1, *Pre-Crack/Fatigue Crack of the Tail Rotor Gearbox Bellcrank Support Horn*, to Transport Canada Civil Aviation (TCCA). The Safety Information Letter stated that, in this occurrence, an inspection of the wreckage revealed a suspicious fracture surface of the tail rotor gearbox bell crank support horn.

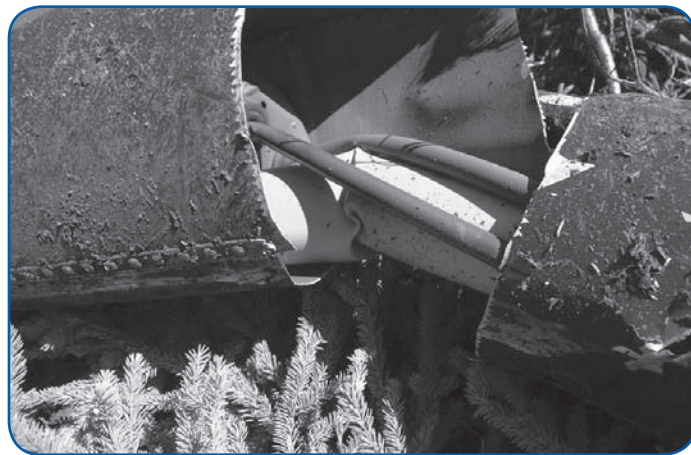
Damage to the aircraft indicated virtually no rotation of the tail rotor at the time of ground contact, but there was evidence of low-power main rotor rotation. The engine was producing power but this power was not being transferred to the tail rotor. It was most likely that the tail rotor drive shaft failed at the forward section, but evidence to confirm this was lost in the post-crash fire. Failure of the tail rotor drive shaft would result in an uncommanded rotation of the helicopter around the vertical axis. The helicopter response to changes in throttle setting corresponds to what would be expected for a loss of tail rotor drive. There was insufficient altitude to effect recovery before ground impact.

*This photo shows no twisting or torsional damage to the tail rotor drive shaft (the big tube), just a bending failure where the main rotor struck the tail boom.*
