Transport  
Canada

TP 185E  
Issue 4/2012

# AVIATION SAFETY LETTER

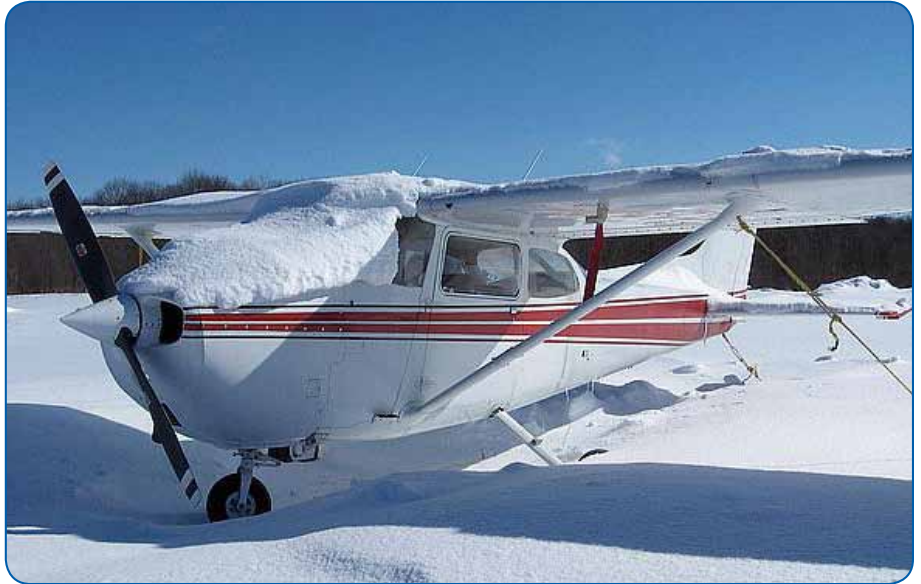
*Aircraft parked unprotected from ice and snow as shown above, require inspection for possible damage and for the presence of ice in the tailcone or elevator assembly prior to flight.*

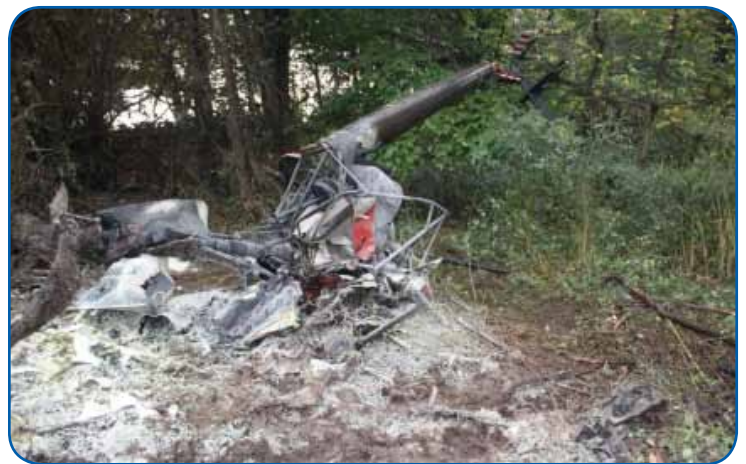
Examination of the helicopter engine indicates that it was not running on impact and that the helicopter struck the ground in a 50° nose-down attitude, suggesting an in-flight loss of control. Although the helicopter was extensively damaged, there were no signs of any pre-impact mechanical failure or system malfunction that could have contributed to this accident. As a result, this analysis focuses on possible scenarios for what

1. It is likely that, while attempting to apply carburetor heat, the pilot inadvertently pulled the mixture control knob to the idle cut-off position, causing the engine to shut down.
2. It is likely that the plastic guard had not been placed over the mixture control knob, resulting in the pilot being able to pull the control to the cut-off position.
3. Following the engine shutdown, the rotor RPM was allowed to decay, resulting in a loss of control and uncontrolled flight into the terrain.
4. With few visual references, the pilot likely became spatially disoriented, contributing to the inability to maintain control.

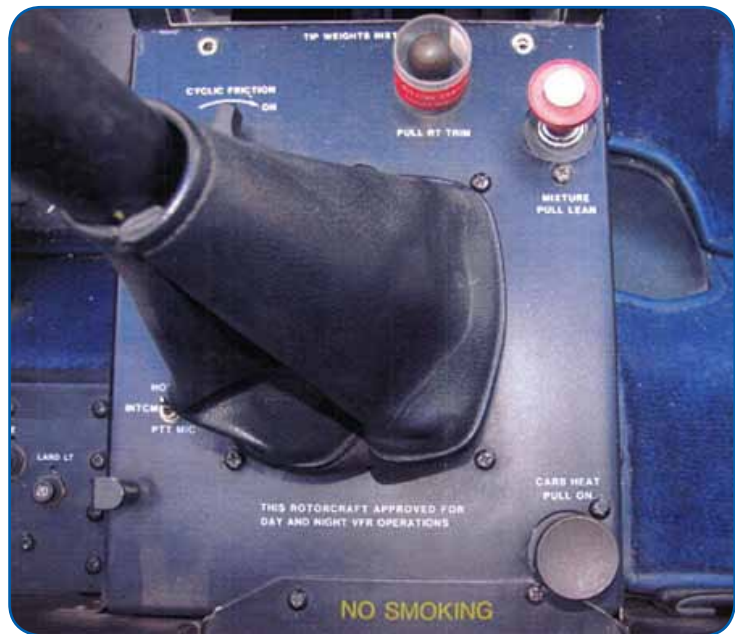
While it was not possible to determine accurately the position of the carburetor heat control before impact, the mixture control knob was found out and bent. With the push-button locking feature, it is unlikely that the mixture control moved during the impact. It was, therefore, likely in the idle cut-off position on impact.

*Centre pedestal with mixture control (upper right) and carburetor heat control (lower right)*

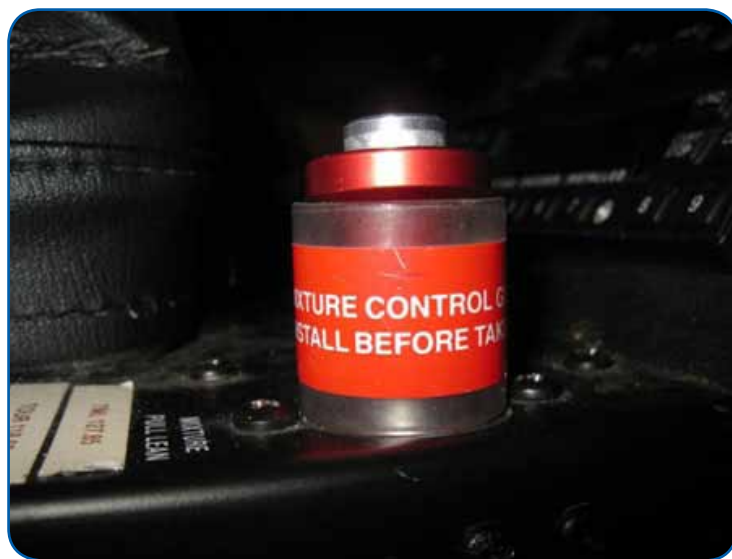
*Mixture control pushed in to full rich with guard installed*

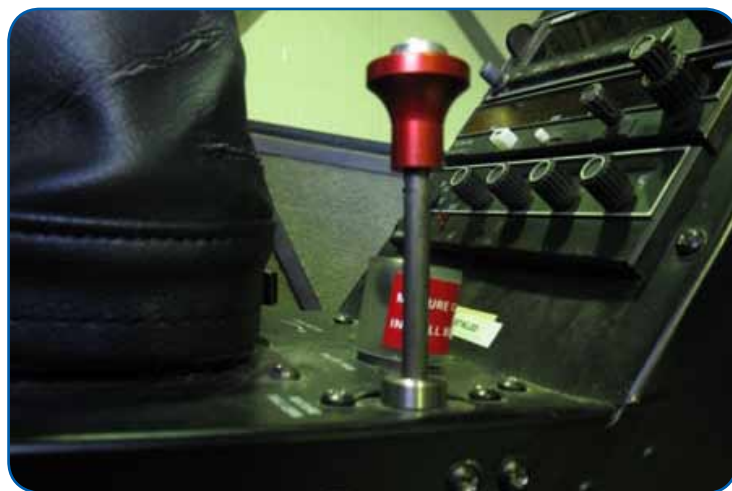
and would also provide tactile feedback that the pilot was attempting to move the wrong control knob. In order for the pilot to be able to pull the mixture control knob to the idle cut-off position, it is likely that the plastic guard had not been placed over the mixture control knob as required.

*Mixture control pulled out to idle cut-off with guard removed*

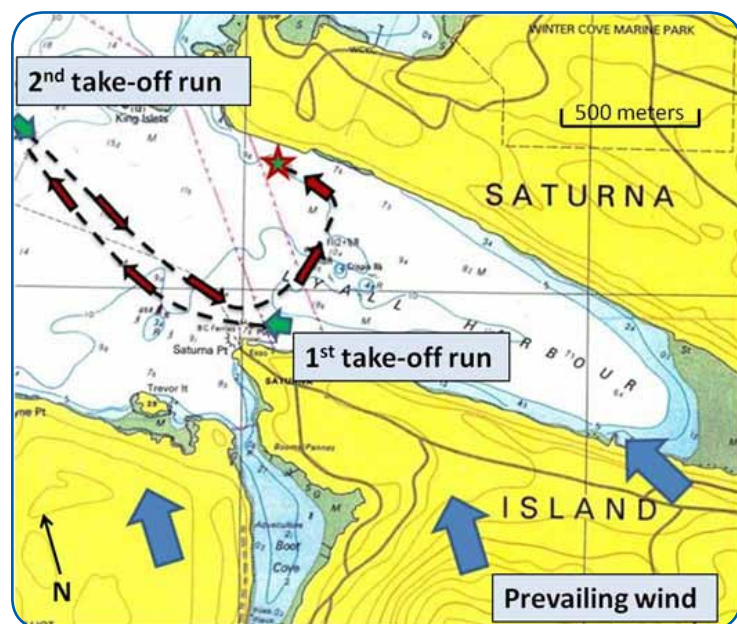
Following takeoff, after the initial climb, the pilot commenced a left turn out of the harbour. The aircraft encountered down flowing air, restricting its ability to gain altitude. As the aircraft turned, it drifted towards terrain, causing the pilot to increase the bank angle. To maintain altitude while banking, the pilot likely had to increase the angle of attack, thereby increasing the load factor and the speed at which the aircraft would stall. While the use of flap may have increased the wing area and consequently decreased its loading, it was likely insufficient to counteract the combined loads brought about by the atmospheric conditions and increase in bank.

*Lyall Harbour with flight route and winds*

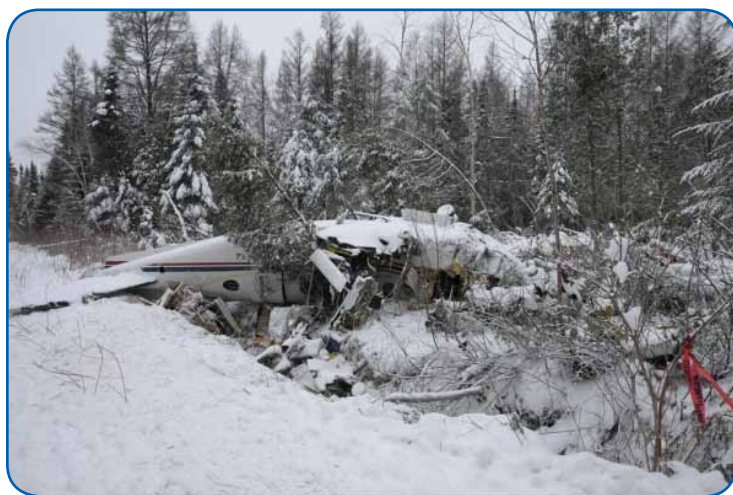
Aircraft wreckage

On December 9, 2009, a Beech A100 was on an instrument flight rules (IFR) flight between Val-d'Or, Que., and Chicoutimi/Saint-Honoré, Que., with two pilots and two passengers on board. At 22:40 Eastern Standard Time (EST), the aircraft was cleared for an RNAV (GNSS) Runway 12 approach and switched to the aerodrome traffic frequency. At 22:50 EST, the International satellite system for search and rescue detected the aircraft's emergency locator transmitter (ELT) signal. The aircraft was located at 02:24 EST in a wooded area approximately 3 NM from the threshold of Runway 12, on the approach centreline. Rescuers arrived on the scene at 04:15 EST. The two pilots were fatally injured, and the two passengers were seriously injured. The aircraft was destroyed on impact; there was no post-crash fire.

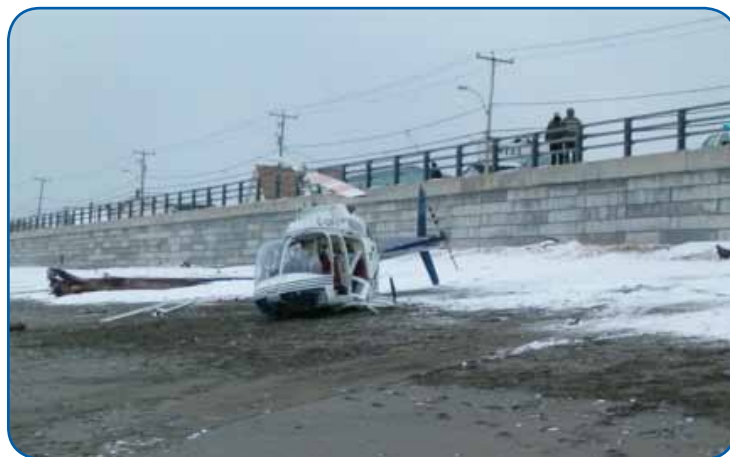
The No. 2 bearing assembly in the engine broke down due to the fatigue failure of its cage. Because this bearing served as a thrust bearing, its failure caused the compressor to move forward, which in turn brought the impeller into contact with the shroud. The resulting friction led to significant deceleration and a loss of power. The propulsive movement of the compressor caused it to stall, as demonstrated by the bangs it produced.

1. The No. 2 bearing assembly in the engine broke down due to the fatigue failure of its cage. The failure of the bearing assembly caused the engine to lose power.
2. The power loss caused a rapid drop in rotor RPM to the point where the LOW ROTOR RPM warning horn sounded during the descent. It can be deduced that the collective was not completely lowered and that rotor RPM dropped below 90 percent. This caused a hard landing.

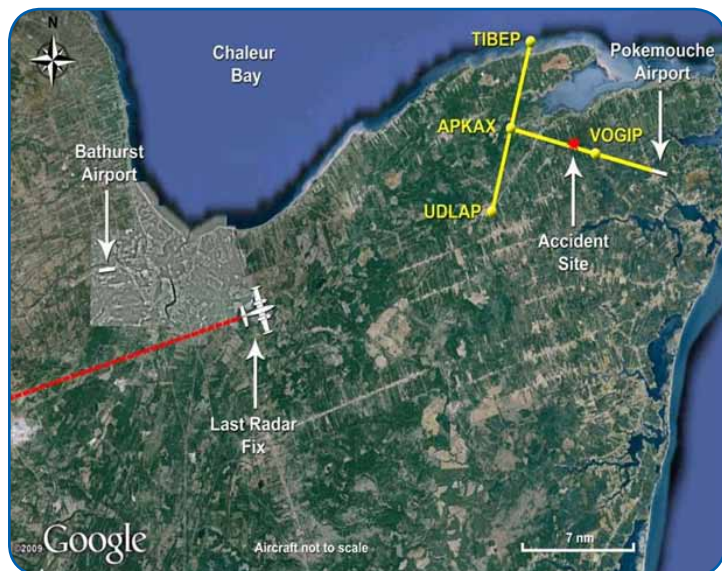
On the day of the occurrence, the departure altimeter setting for St-Hubert was 29.61 in. Hg and the arrival altimeter setting for Bathurst, N.B., was 29.41 in. Hg. If the Bathurst altimeter setting was not applied prior to the commencement of the instrument approach, the aircraft's actual altitude would have been 200 ft lower than indicated on the altimeter. While an altimeter error of this nature would reduce safety margins, levelling off at the minimum descent altitude with the incorrect altimeter setting of 29.61 in. Hg would still provide several hundred feet of clearance between the aircraft and the terrain. As a result, it is unlikely that the aircraft impacted the ground simply because the altimeter had not been switched to the current Bathurst altimeter setting.

*Aircraft flight path to Pokemouche Airport*

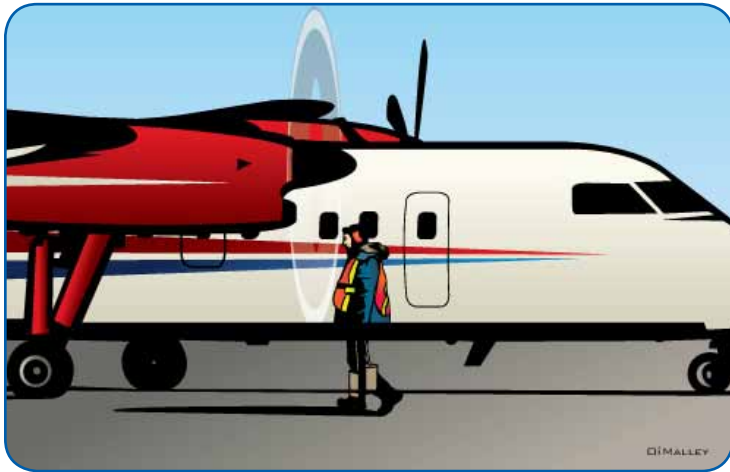
*Despite constant reminders, warnings, and on-the-job training, marshallers sometimes forget about turning propellers.*
