Transport  
Canada

TP 185E  
Issue 1/2016

# AVIATION SAFETY LETTER

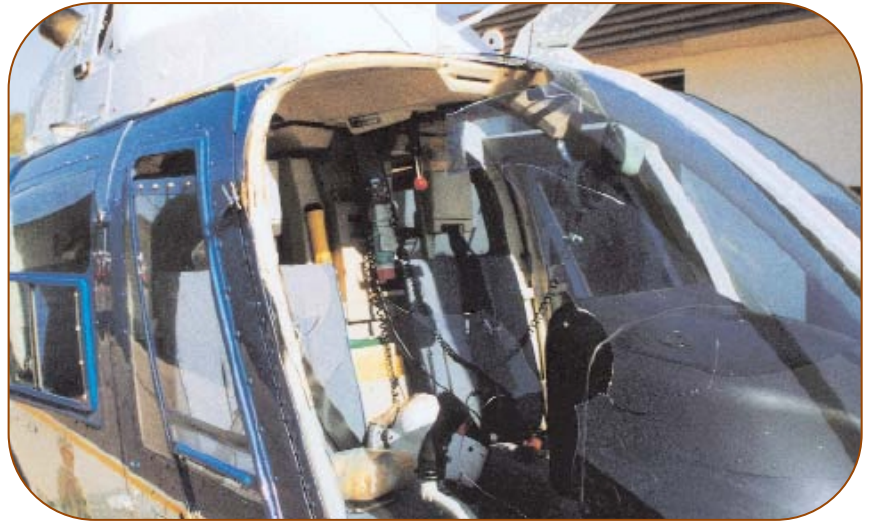
*An impact with a Western Grebe (3 lbs) caused considerable damage to this helicopter. The bird struck the pilot in the face.*

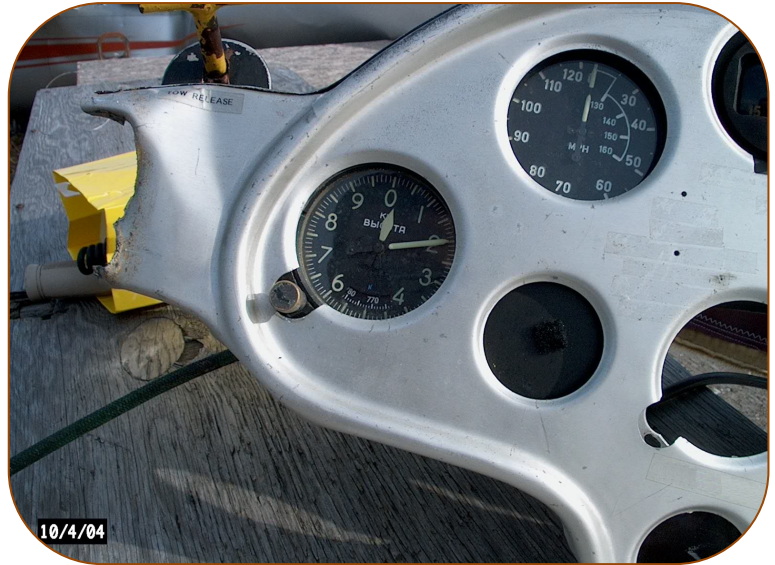
*Rear instrument panel from the Blanik, showing the altimeter in meters.*

Evidence could not be found relating the mixed instrumentation to a role in the accident; nevertheless, the coroner recommended that the aviation community be made aware of the increased possibility of error when operating aircraft with mixed instrumentation. For instance, a pilot who normally flies with a traditional altimeter in feet, and who is suddenly made to fly with an altimeter in meters could misinterpret—in a busy moment—his or her altitude.

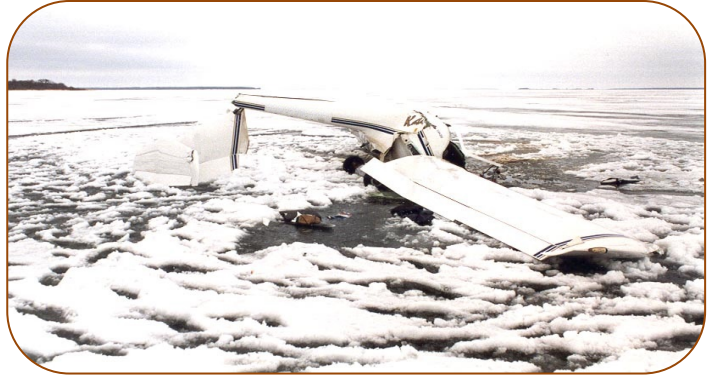
*DA20 accident at Lake Manitoba in February 1998  
(TSB file A98C0030)*

In February 1998, a DA20 Katana crashed on the frozen surface of Lake Manitoba killing both the flight instructor and the student. It was determined that the flight pressed on into poor weather until it encountered whiteout conditions.<sup>1</sup>

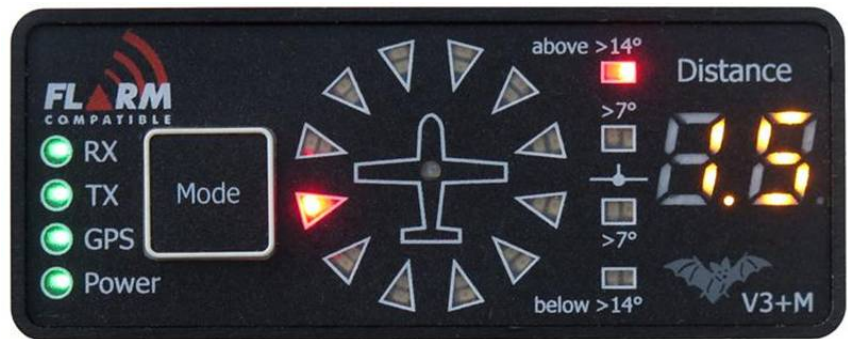
*Example of FLARM display provided by FLARM Technology Ltd.*

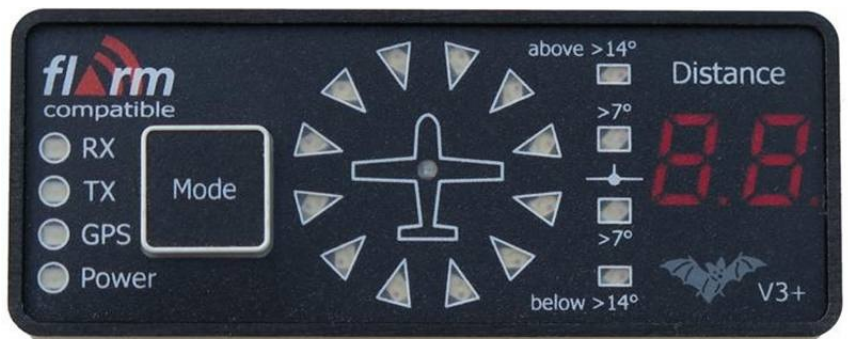
*Example of FLARM display provided by FLARM Technology Ltd.*

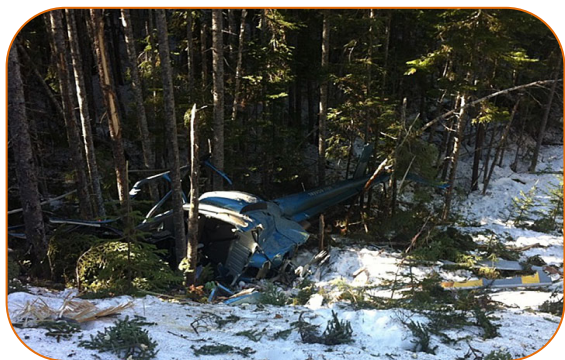
*Impact site (Source: Héli-Boréal)*

On 13 May 2014, an Eurocopter AS 350 BA helicopter was on a flight to inspect power-line vegetation encroachment with a pilot and an observer on board. The flight surveyed a 25-kilovolt power distribution line, which ran adjacent to a service road leading to Hydro-Québec's Sainte-Marguerite power dam. While completing a right turn in a valley, the pilot noticed a 315-kilovolt power transmission line crossing perpendicular to the direction of flight. The right turn was increased to avoid the transmission line, but one of the helicopter's main rotor blades struck the lower wire. The resulting damage to the rotor blade caused severe vibrations, which made it difficult to control the helicopter. While on approach to land in a small clearing under the 315-kilovolt transmission line, the helicopter's skid gear contacted trees. The helicopter rolled to the left and fell approximately 50 ft through the trees, coming to rest on its left side in the snow. Both occupants sustained serious injuries, yet were able to exit the aircraft. The helicopter was substantially damaged. The 406-megahertz emergency locator transmitter activated on impact. The Cospas-Sarsat International Satellite System for Search and Rescue did not receive a signal until 25 min after the accident. There was no post-impact fire. The accident occurred in daylight hours at 1020, Eastern Daylight Time.

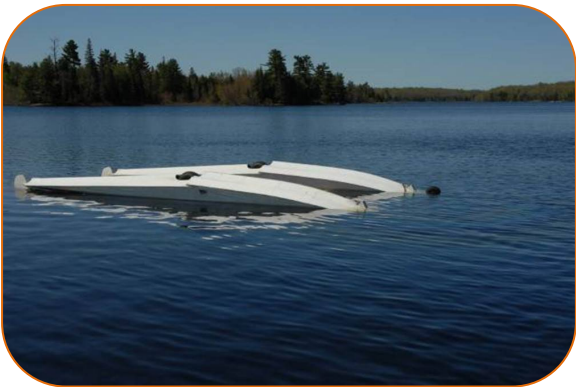
Submerged aircraft.

On 24 May 2014, privately-registered Cessna 185E equipped with amphibious floats, departed the Guelph Airpark for a flight to Taylor Lake, Ontario. The pilot was the sole occupant of the aircraft. While conducting a glassy water landing, the floats dug into the water, the pilot lost control, and the aircraft cartwheeled and sank. The aircraft fuselage was damaged by impact forces, and the pilot's door could not be opened. The pilot survived the impact but was not able to escape the submerged aircraft and drowned. The aircraft was equipped with an emergency locator transmitter which activated; however, no signal was received due to the antenna being submerged. The accident occurred during hours of daylight at approximately 0740, Eastern Daylight Time.
