Transport  
Canada

TP 185E  
Issue 3/2014

# AVIATION SAFETY LETTER

## Bell 204 Tail Rotor Pitch Link Bolt Failure...

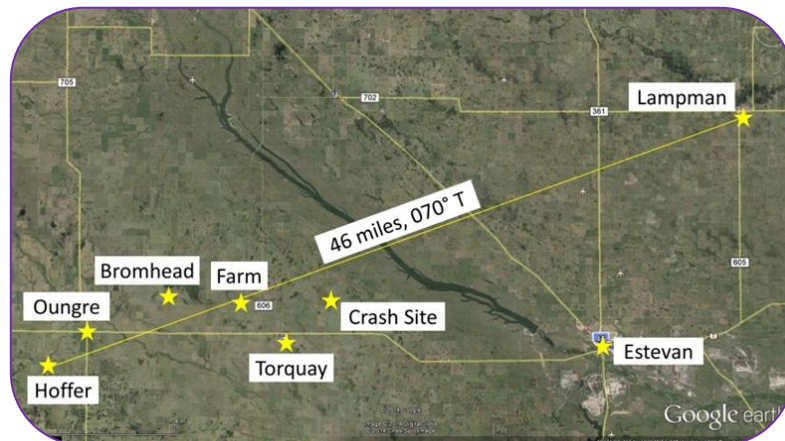
Figure 1: Area of planned flight

The flight was conducted under VFR on a flight itinerary from a private aerodrome at Hoffer, Sask., to Lampman, Sask. (see Figure 1). The purpose of the pleasure flight was to attend a breakfast being held at the Lampman airport. A group in a second aircraft was also going to the breakfast and departed from the Hoffer aerodrome first, with the accident aircraft departing shortly afterward, at approximately 07:30.<sup>2</sup>

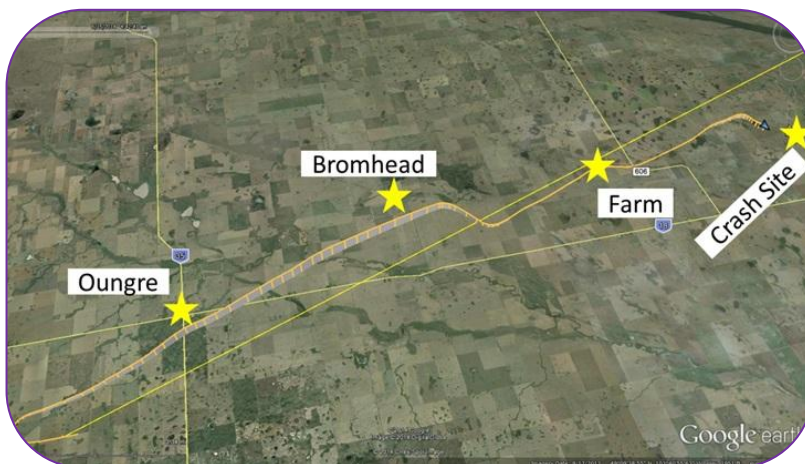
Figure 2: Cessna 172C flight path

The aircraft was equipped with a Garmin Aera 510 global positioning system (GPS), and the TSB Engineering Laboratory recovered GPS data from the accident flight (see Figure 2 for the flight path). The final GPS position recorded was about ¾ mi. before the initial point of impact.

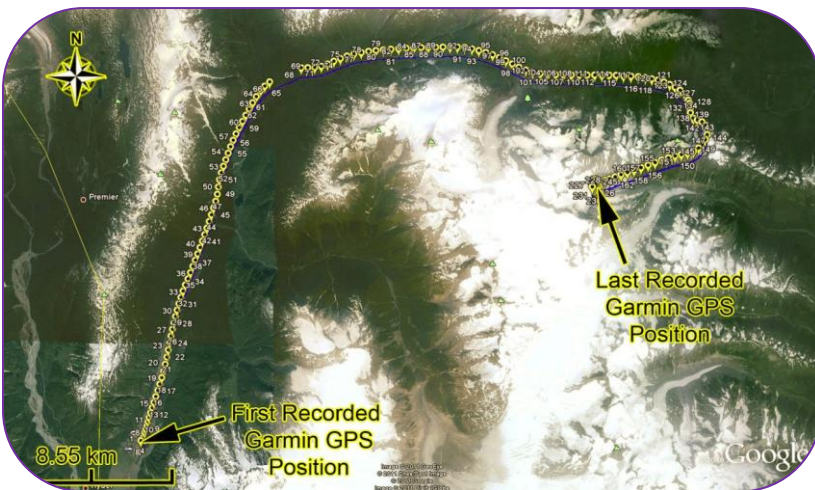
*Photo of GPS data showing the flight track  
(Image: Google Earth; diagram added by TSB)*

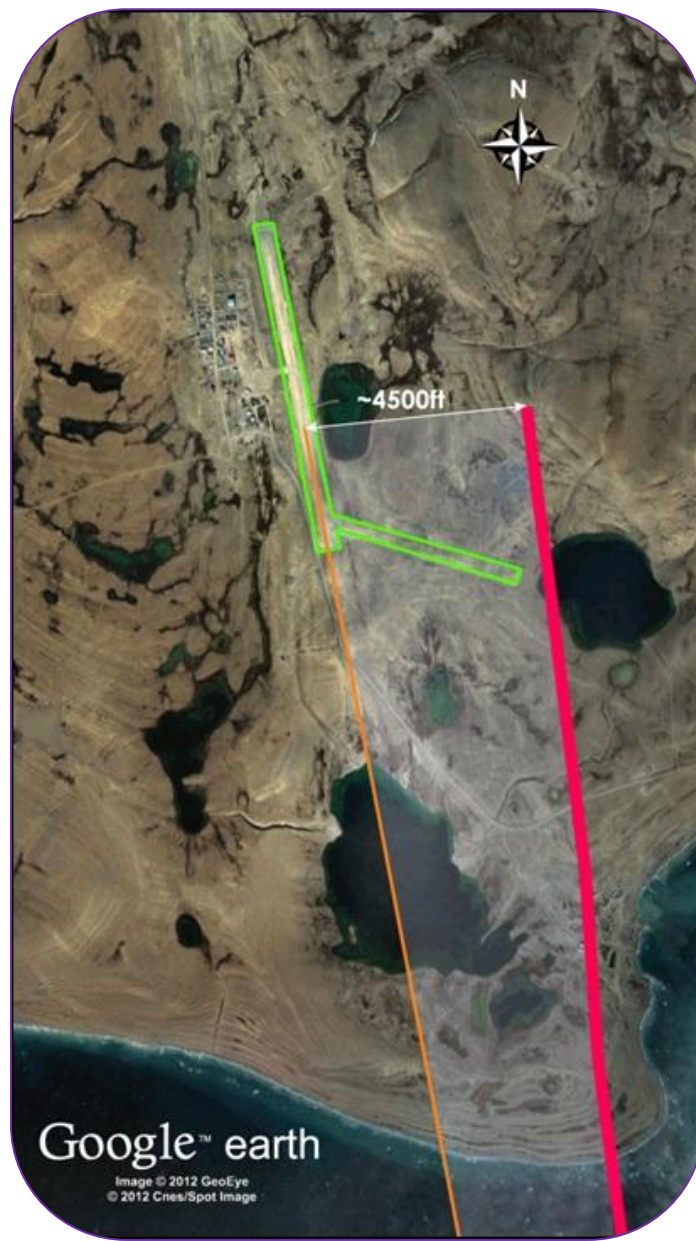
*Final approach track relative to runway  
(image: Google Earth, with annotations by TSB)*

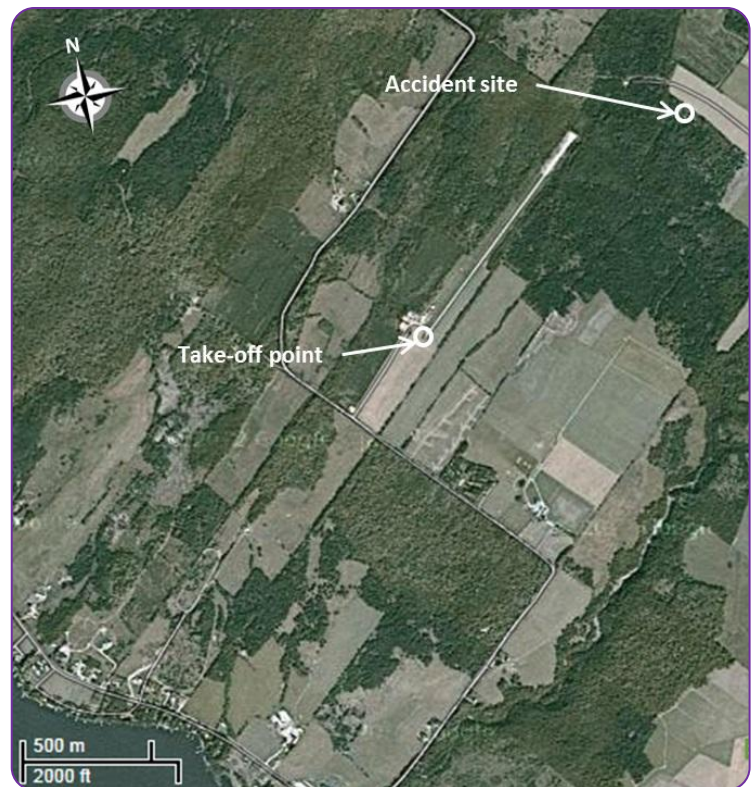
*Aerial view of the Saint-Ferdinand area*

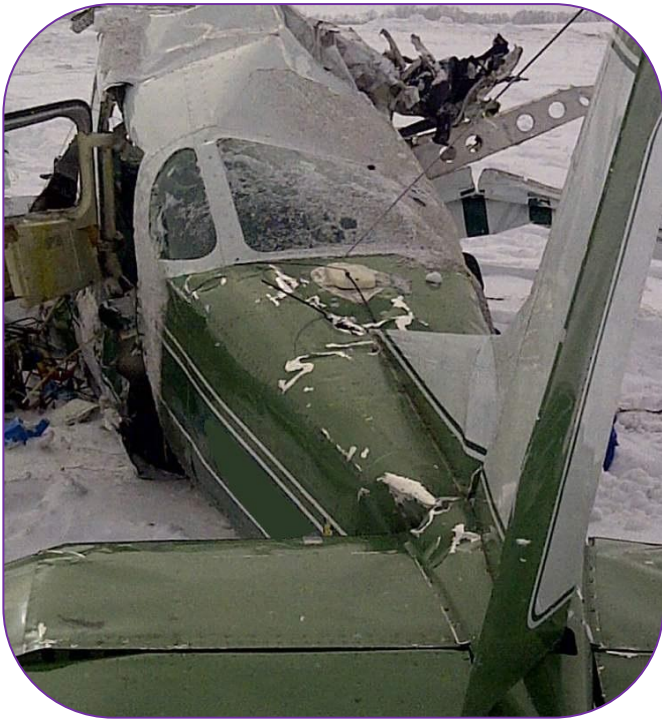
On February 10, 2013, at approximately 12:30 CST, a privately registered Cessna 210C departed a private airstrip located at Waskada, Man., with a pilot and three passengers on board for a sightseeing flight in the local area. Approximately 30 min after the aircraft departed, fog moved into the area. At 13:17 CST, an ELT signal was received in the area. A search was undertaken and the wreckage was located 3 NM north of Waskada. All occupants suffered fatal injuries. There was no post crash fire. *The TSB authorized the release of this report on January 29, 2014.*

The snow-covered terrain, combined with the meteorological conditions, was conducive to whiteout. In whiteout conditions, the snow and fog would blend together and under these conditions, the pilot would not be able to fly using visual references. Whiteout would also make it more difficult to identify an area of local fog and more difficult to exit such an area if it were encountered.

It is therefore probable that the pilot encountered whiteout conditions and was unable to accurately judge, through visual reference, his altitude above the ground. In the absence of a visible horizon, the pilot likely experienced spatial disorientation, particularly if he initiated a turn to avoid the deteriorating weather. The pilot's lack of instrument training and experience would have made him more susceptible to the effects of whiteout and spatial disorientation.

1. The meteorological conditions in the area were conducive to whiteout.
2. The pilot likely flew inadvertently into IMC and lost situational awareness and control of the aircraft, resulting in impact with terrain.
