Transport  
Canada

TP 185E  
Issue 4/2012

# AVIATION SAFETY LETTER

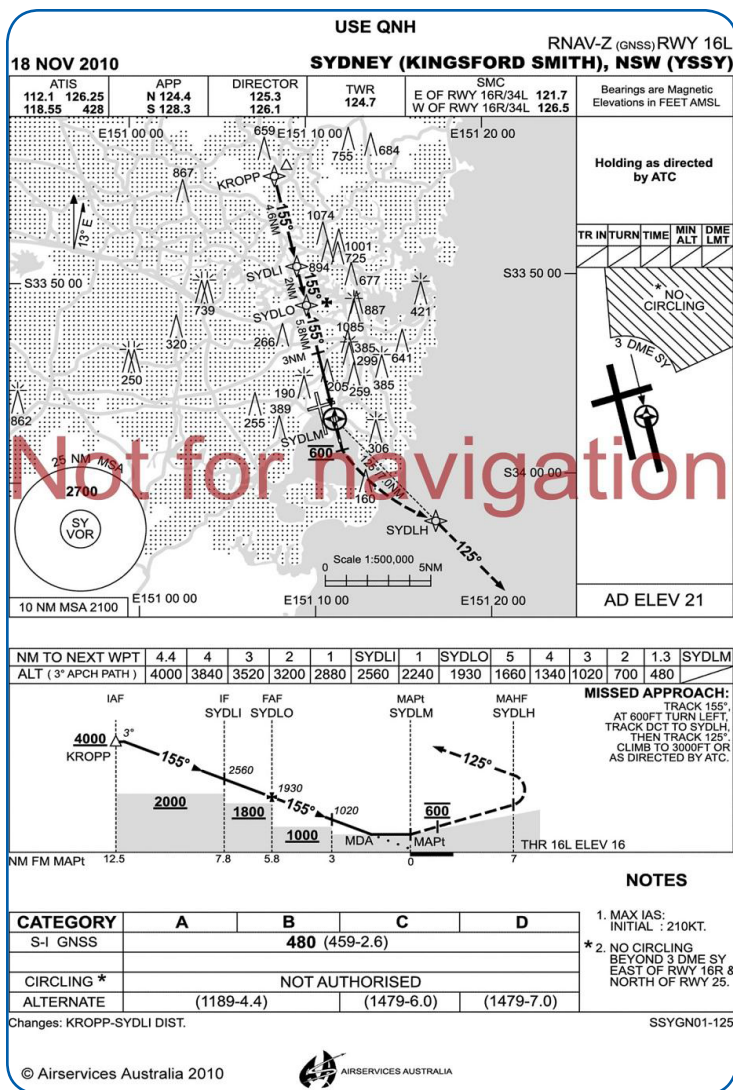
Figure 1.

The captain reported initially being high on profile during the approach; however, by the 'SYDLI' intermediate fix (Figure 1), the aircraft was back on profile but, as a result, needed to slow down. In response, the captain selected the propeller control levers to maximum RPM, which changed the pitch of the propellers and effected a significant slowing of the aircraft. In addition, the first officer reported that

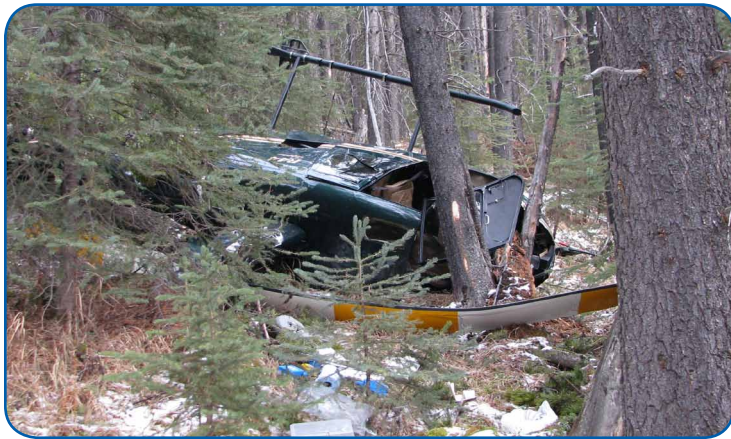
### **TSB Final Report A09W0021—Loss of Power and Collision with Terrain**

On January 30, 2009, a Robinson R44 helicopter was en route from Grande Prairie, Alta., to Grande Cache, Alta., with one pilot and one passenger on board. At approximately 17:02 Mountain Standard Time (MST), while climbing over rising terrain, the helicopter lost engine power and main rotor RPM. The pilot turned downhill in an effort to regain main rotor RPM. When this failed, he carried out a forced landing into the trees where the aircraft came to rest on its right side. The pilot was seriously injured when the passenger fell on top of him during impact. The passenger sustained no injury. They spent more than 15 hr on site before being rescued. The emergency locator transmitter (ELT) did not activate during the impact sequence, thus delaying the search and rescue (SAR) response.

The weather at the time of the accident was conducive to the formation of carburetor icing. The pilot had spent most of his career flying turbine-powered helicopters, in which carburetor icing is not a concern. The carburetor heat lever can move away from the required position through movement of the collective arm in flight. The reported loss of power was likely the result of carburetor icing, which could not be corrected by the pilot in the time available.

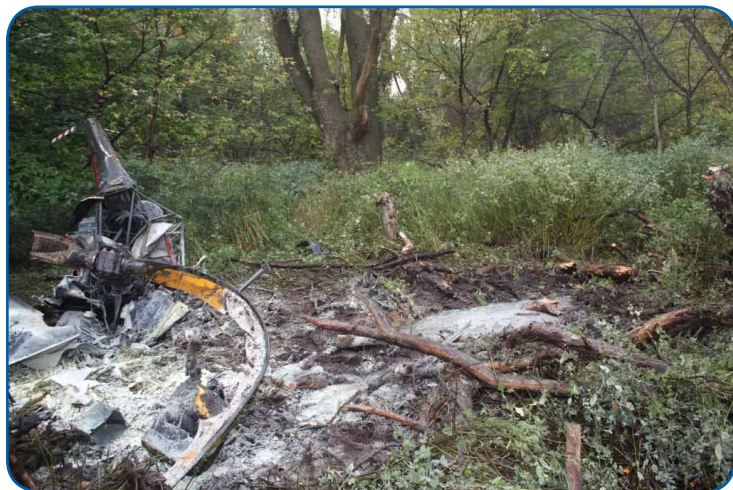
With a lack of visual reference at night, limited visibility due to weather and the pilot's relative inexperience, the pilot likely became spatially disoriented while dealing with the power loss emergency. Unable to determine the correct attitude of the helicopter without visual reference, the pilot lost control, resulting in uncontrolled flight into the terrain.

1. It is likely that, while attempting to apply carburetor heat, the pilot inadvertently pulled the mixture control knob to the idle cut-off position, causing the engine to shut down.
2. It is likely that the plastic guard had not been placed over the mixture control knob, resulting in the pilot being able to pull the control to the cut-off position.
3. Following the engine shutdown, the rotor RPM was allowed to decay, resulting in a loss of control and uncontrolled flight into the terrain.
4. With few visual references, the pilot likely became spatially disoriented, contributing to the inability to maintain control.

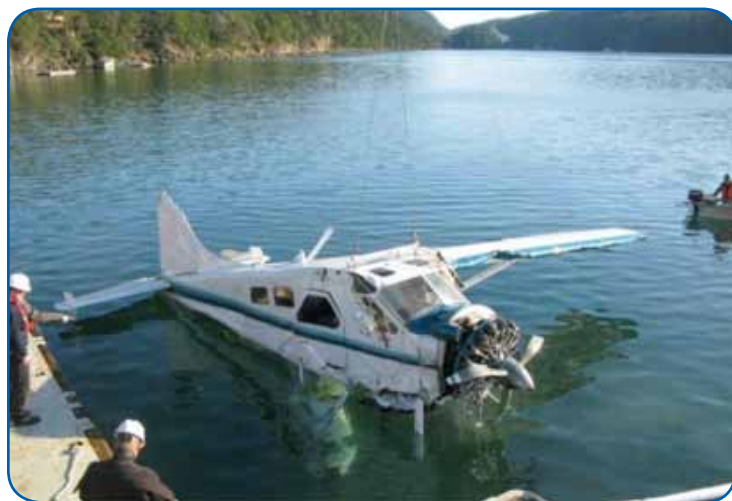
On November 29, 2009, a de Havilland DHC-2 MK 1 was departing Lyall Harbour, Saturna Island, B.C., for the water aerodrome at the Vancouver International Airport, B.C. After an unsuccessful attempt at taking off downwind, the pilot took off into the wind towards Lyall Harbour. At approximately 16:03 Pacific Standard Time (PST), the aircraft became airborne, but remained below the surrounding terrain. The aircraft turned left, then descended and collided with the water. Persons nearby responded immediately; however, by the time they arrived at the aircraft, the cabin was below the surface of the water. There were eight persons on board—the pilot and an adult passenger survived and suffered serious injuries; the other six occupants drowned inside the aircraft. No signal from the emergency locator transmitter (ELT) was heard.

The DHC-2 Beaver was originally certified without a stall warning system. One had been installed on the occurrence aircraft, but was later rendered unserviceable. The absence of a functioning stall warning system, coupled with the known benign stalling characteristics of the Beaver, precluded any warning of an impending stall. Furthermore, the stall warning horn had been filled with silicone to make it less noisy. It is therefore possible that a horn would not be heard during periods of loud engine noise, thereby increasing the risk of inadvertent stalls.

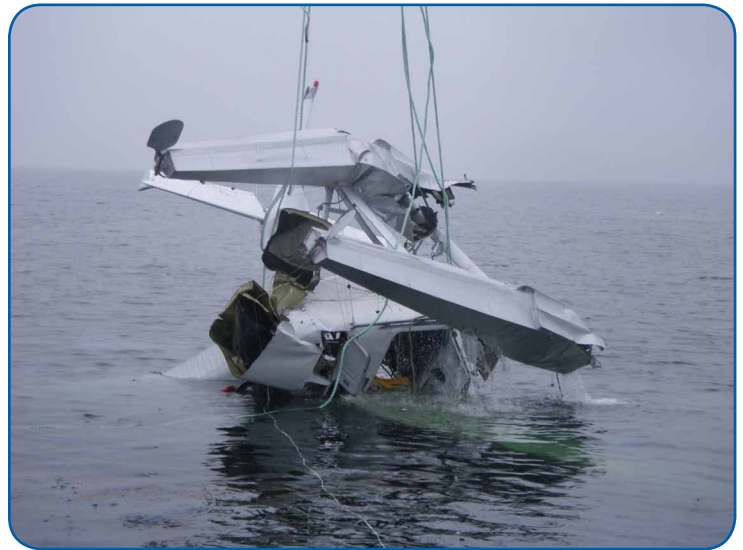
On May 29, 2010, a float-equipped Cessna 185F took off from Tofino, B.C., at 12:00 Pacific Daylight Time (PDT) for a flight to Ahousat, B.C., with a pilot and three passengers. The short flight was being carried out under visual flight rules (VFR) at about 500 ft above sea level (ASL). About 2 NM from Ahousat, while in cruise flight, the aircraft descended in a steep nose-down attitude until it hit the water in Millar

Channel and overturned. Attempts to secure the aircraft failed and it sank. There were no survivors. The emergency locator transmitter (ELT) functioned but its signal was not received until the wreckage was brought to the surface two days later.

The weather was suitable for the VFR flight; the wind direction and speed would not have caused downdrafts or severe turbulence on the flight route. There was no evidence to suggest that any mechanical or environmental issue played a role in this occurrence.

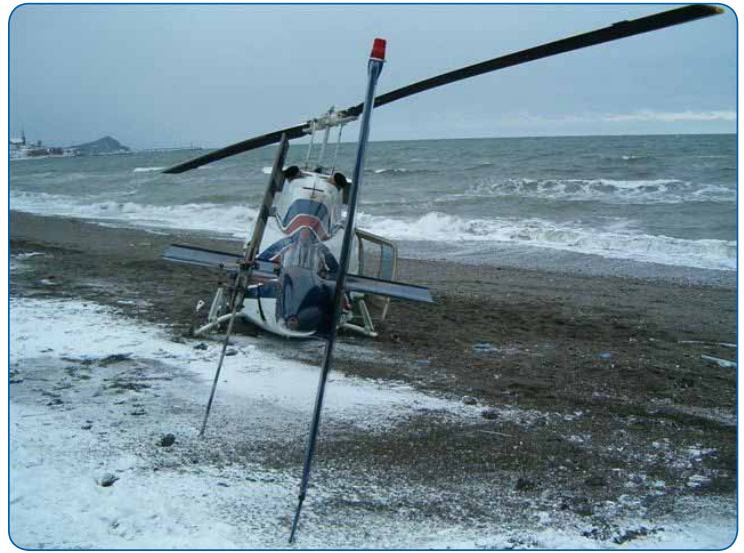
According to the height/speed chart, the loss of power occurred in an operating range within which a safe emergency landing was possible. At the time of the failure, there were three operating conditions posing a greater challenge than usual for the pilot. Given the height of the aircraft, the pilot had little time to lower the collective, perform a 180° turn into the wind, and begin the descent before landing on a slope. The power loss caused a rapid drop in rotor RPM to the point where the low

rotor RPM warning horn sounded during the descent. It can be concluded that the collective was off the down stop and that the rotor RPM fell below 90 percent.

1. The No. 2 bearing assembly in the engine broke down due to the fatigue failure of its cage. The failure of the bearing assembly caused the engine to lose power.
2. The power loss caused a rapid drop in rotor RPM to the point where the LOW ROTOR RPM warning horn sounded during the descent. It can be deduced that the collective was not completely lowered and that rotor RPM dropped below 90 percent. This caused a hard landing.

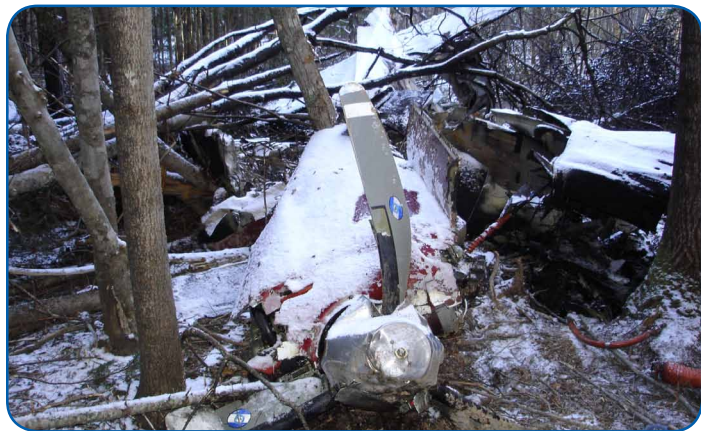
## TSB Final Report A10A0122—Controlled Flight Into Terrain

On December 14, 2012, at 19:41 Atlantic Standard Time (AST), a Cessna 310R departed the Montréal/St-Hubert Airport, Que., on a night instrument flight rules (IFR) flight to the Pokemouche Airport, N.B. Between 21:56 AST and 21:58 AST, three transmissions were received from the occurrence aircraft's 406 MHz emergency locator transmitter (ELT); however, the signal terminated before the location could be determined. The wreckage was located two days later in a wooded area, approximately 5.5 NM west-northwest of the Pokemouche Airport. The aircraft was destroyed by the impact and post-crash fire. The lone occupant was fatally injured.

On the day of the occurrence, the departure altimeter setting for St-Hubert was 29.61 in. Hg and the arrival altimeter setting for Bathurst, N.B., was 29.41 in. Hg. If the Bathurst altimeter setting was not applied prior to the commencement of the instrument approach, the aircraft's actual altitude would have been 200 ft lower than indicated on the altimeter. While an altimeter error of this nature would reduce safety margins, levelling off at the minimum descent altitude with the incorrect altimeter setting of 29.61 in. Hg would still provide several hundred feet of clearance between the aircraft and the terrain. As a result, it is unlikely that the aircraft impacted the ground simply because the altimeter had not been switched to the current Bathurst altimeter setting.
