Transport
Canada

AVIATION SAFETY LETTER

ISSUE 3/2019

TP 185E

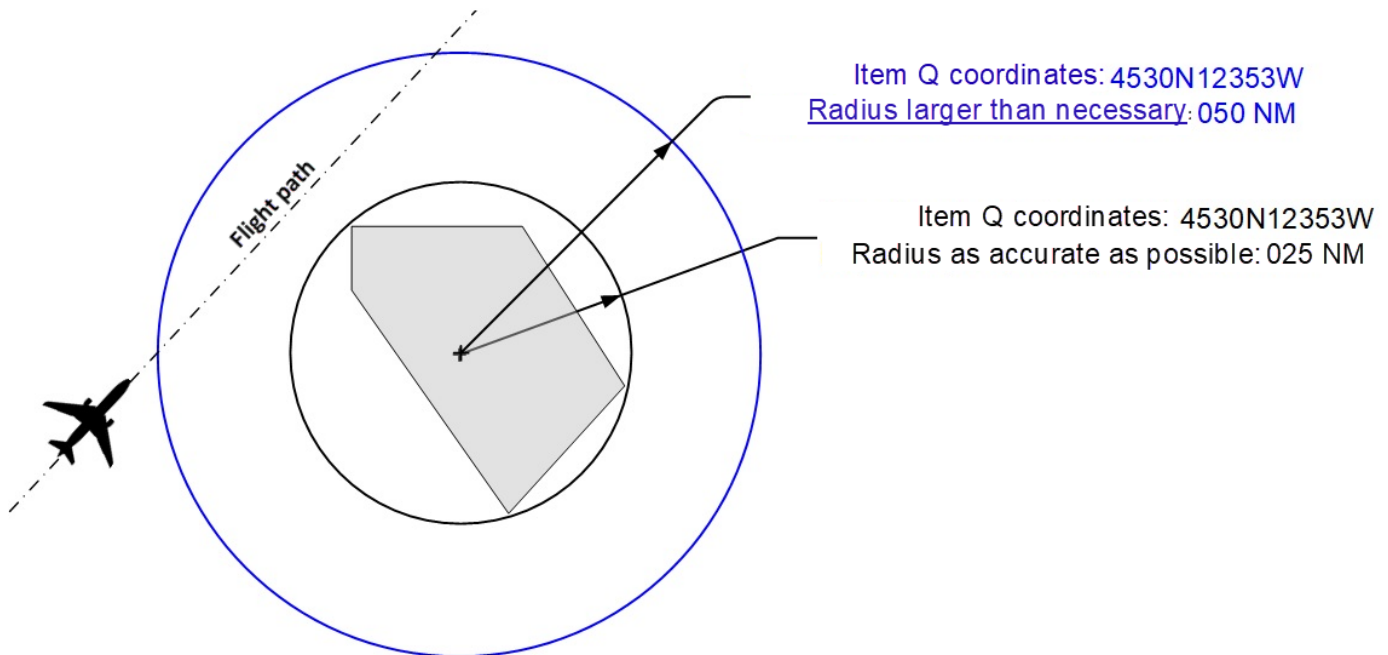
This example shows how a NOTAM radius that is larger than necessary will affect the NOTAMs presented to pilots.

Successful use of the new NOTAM system requires a strict adherence by the originators to the NOTAM specifications (found in the Canadian NOTAM Operating Procedures [CNOP]). For example, if the vertical limits and the radius of influence of the coded-line are much smaller than they should be, a NOTAM may be omitted from a briefing when it should be included. Conversely, values that are too large may cause a NOTAM to be added to a briefing when it should be omitted.

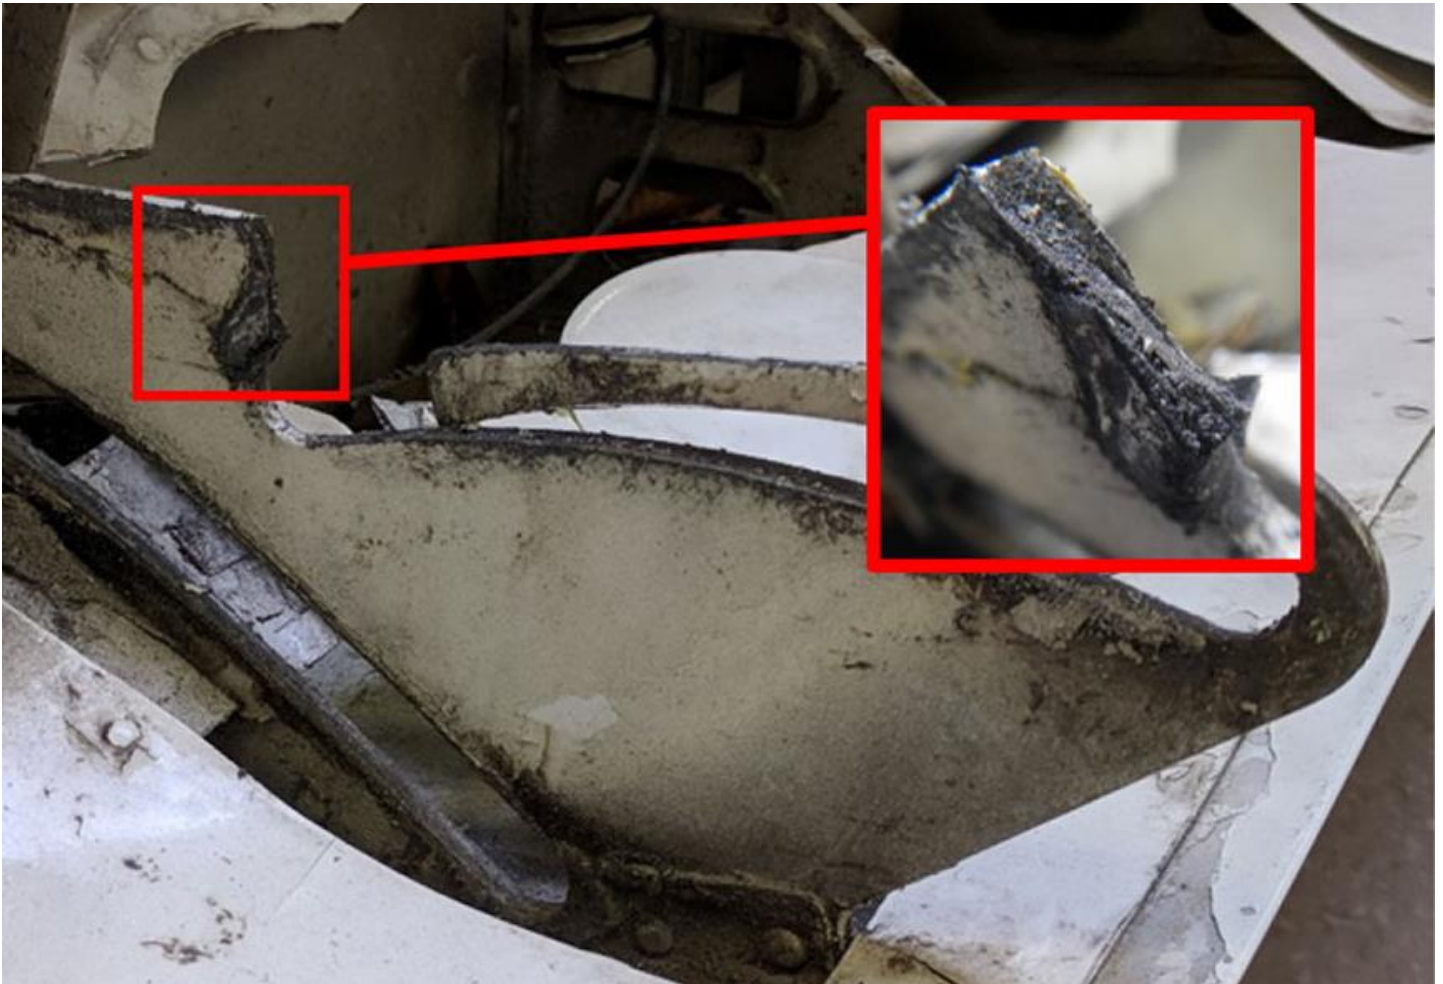
Figure 1. The fractured flap track, with an expanded view of the fractured area

The forward section of the left wing inboard aft flap track was fractured (Figure 1). As a result, the left flap inboard aft roller, which is normally positioned inside the associated flap track, was located outside of the broken flap track.

The outboard flap track was still intact and, as a result, it was possible for the left flap to be cocked in position, preventing it from travelling

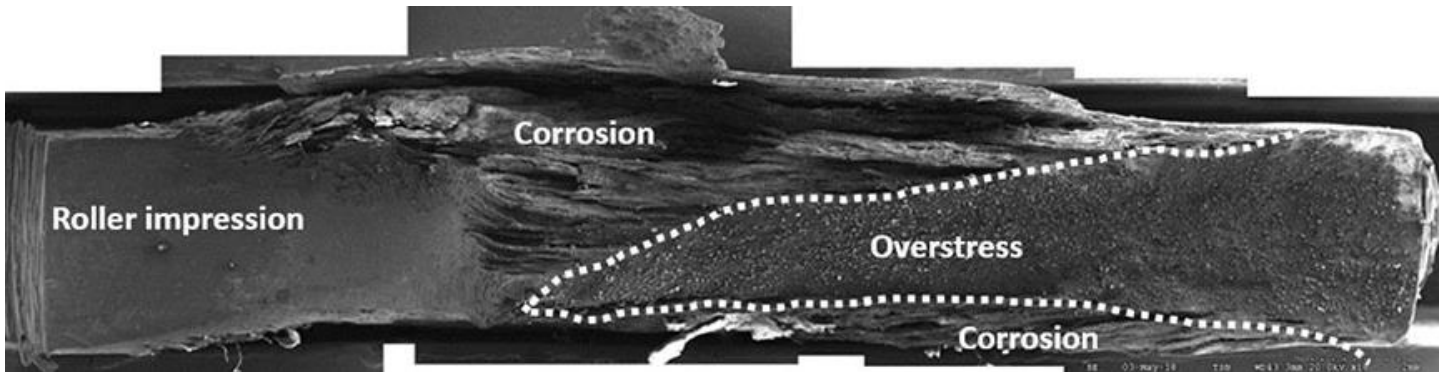
Figure 2. Scanning electron microscope image of the fractured flap track, showing areas of corrosion, overstress, and the flap roller impression on top of corrosion

The fractured surface of the inboard flap track was examined with a scanning electron microscope. It was determined that the damage was caused by corrosion, which gave the appearance of delamination (Figure 2). The corrosion had been present prior to the occurrence; however, when or how it began could not be determined. Corrosion has a detrimental effect on the strength of an aluminum component and can significantly diminish the structural integrity and life expectancy of an aircraft component.

The fracturing of the non-corroded portion of the flap track was caused by overstress from a combined shear and tension load. However, it could not be determined whether this happened before or during impact.

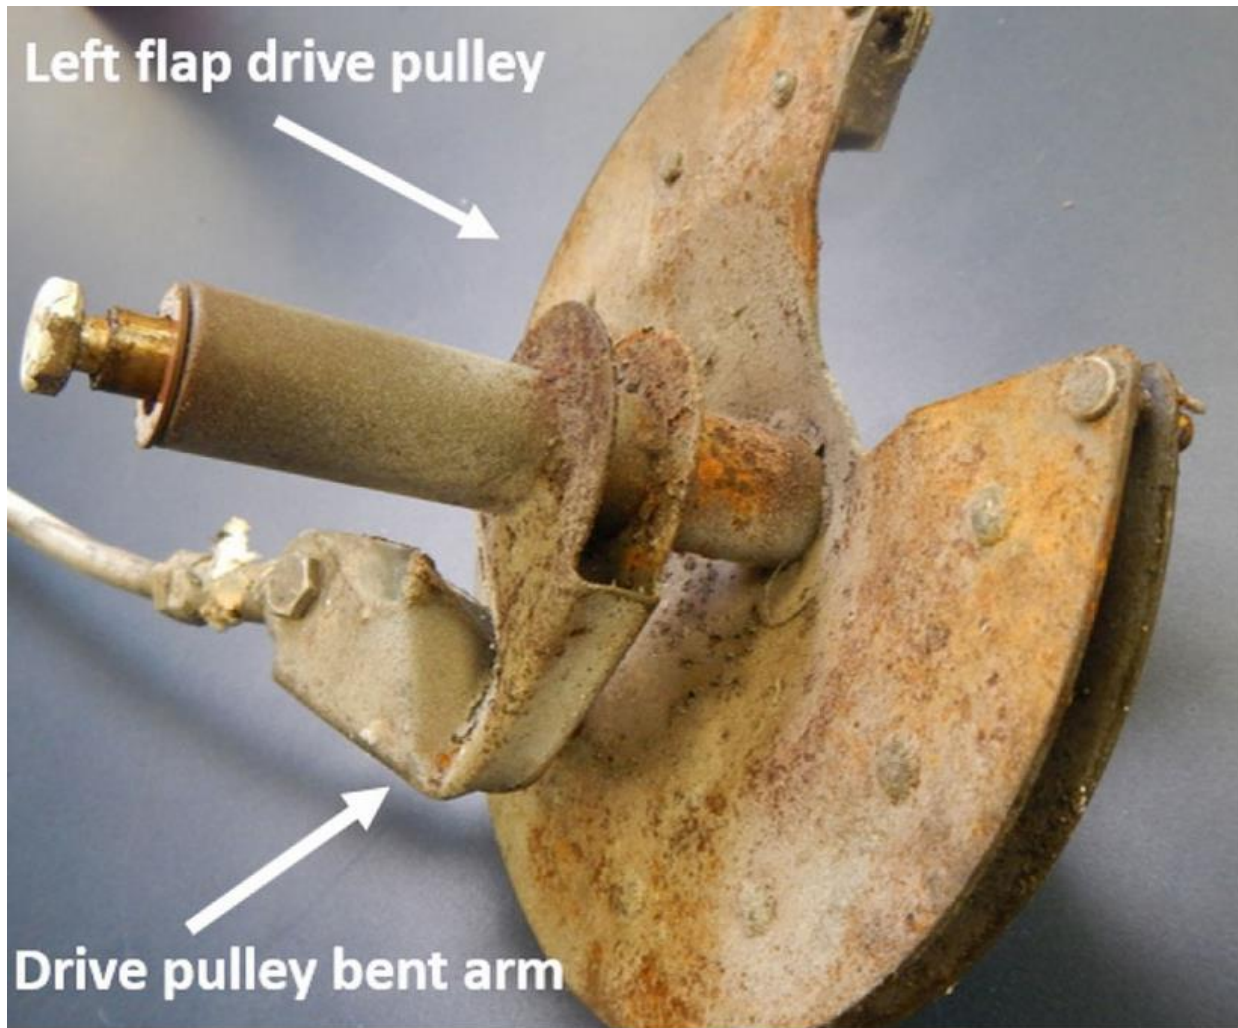
Figure 3. The left flap drive pulley

The arm attached to the flap drive pulley in the left wing was bent almost 90° from its original position as a result of tensile overload (Figure 3). It is possible that this damage occurred during the impact sequence. However, there was no corresponding damage to the left flap, which is connected to the drive pulley arm via a push-pull rod. It is also possible that the bending of the drive pulley arm occurred during operation of the flaps. If the left flap was unable to move, the arm may have been bent from the cable tension produced by the flap actuator.

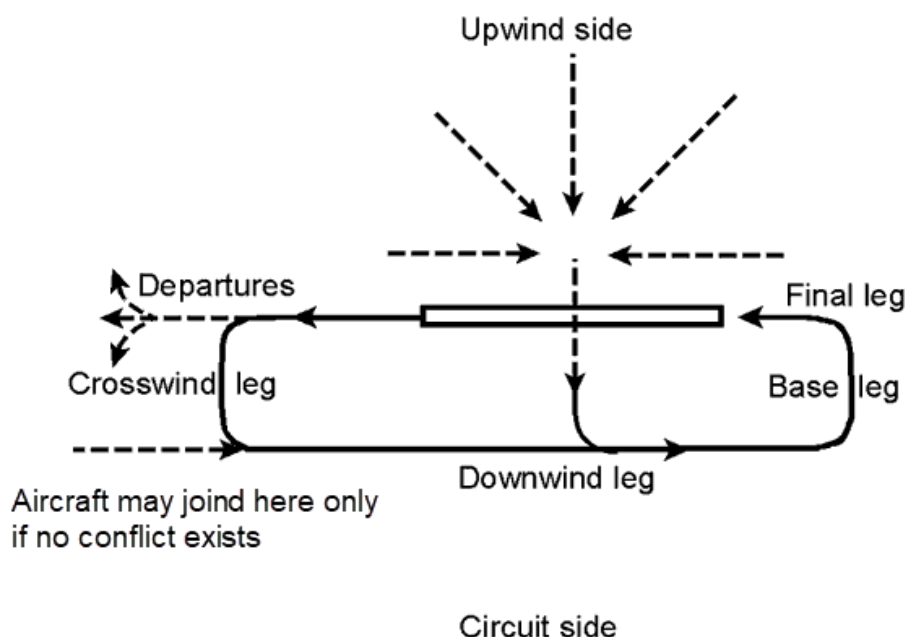
20. You are joining the circuit straight in on the downwind for a left pattern at an uncontrolled airport and you hear another pilot joining overhead crosswind but cannot see this pilot. What would you do?

Reference: TC AIM RAC 4.5.2 and Figure 4.6 Standard Left-Hand Circuit Pattern

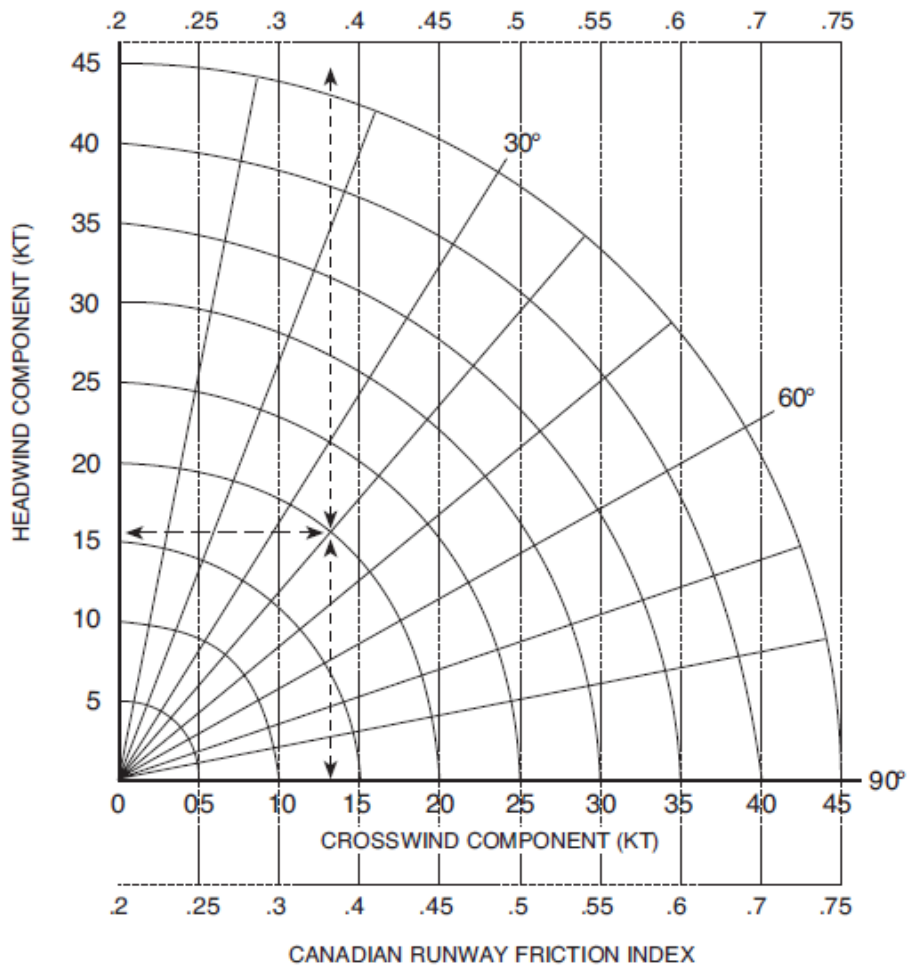
50. What would be the crosswind limit when the CFRI index is .25? _____

Reference: TC AIM AIR 1.6.6 Using Figure 1. 1 Crosswind Limits for CFRI char

- 45.
 1. Control aircraft-establish a glide.
 2. Choose your landing area.
 3. Plan your approach. Refer to the POH/AFM for specific details as time permits.
- 46. See your POH/AFM
- 47. 200 ft; go-around
- 48. sudden application of power; use appropriate elevator and control attitude.
- 49. 10 kts of crosswind.
- 50. Max. crosswind limit of 5 kts.
- 51.
