Transport  
Canada

TP 185E  
Issue 4/2013

# AVIATION SAFETY LETTER

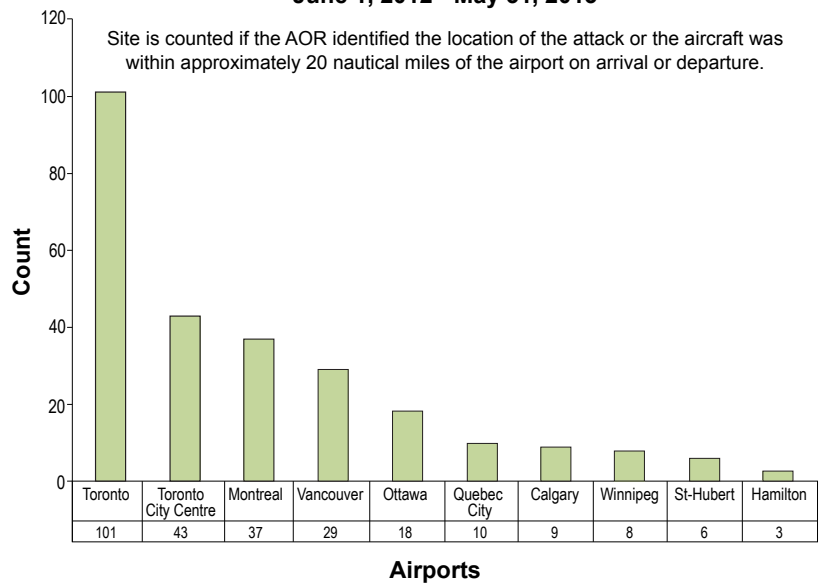
### Top Airports for Laser Attacks

June 1, 2012 - May 31, 2013

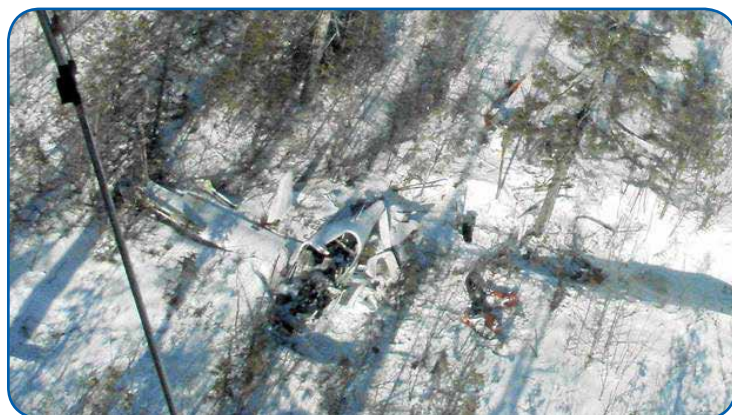
Wreckage debris and broken tree limbs were scattered about 300 ft along an approximate 200° magnetic heading from a broken tree. The airplane came to rest in approximately 6 ft of snow. The nose and the engine broke away from the fuselage and were buried in the snow. The cockpit of the airplane was exposed and the canopy broke away along the debris path. The right wing was attached to the fuselage but fragmented. The empennage broke away from the fuselage and was buried in snow along the debris path. The left wing broke away from the fuselage at the wing root and fragmented in the snow along the debris path.

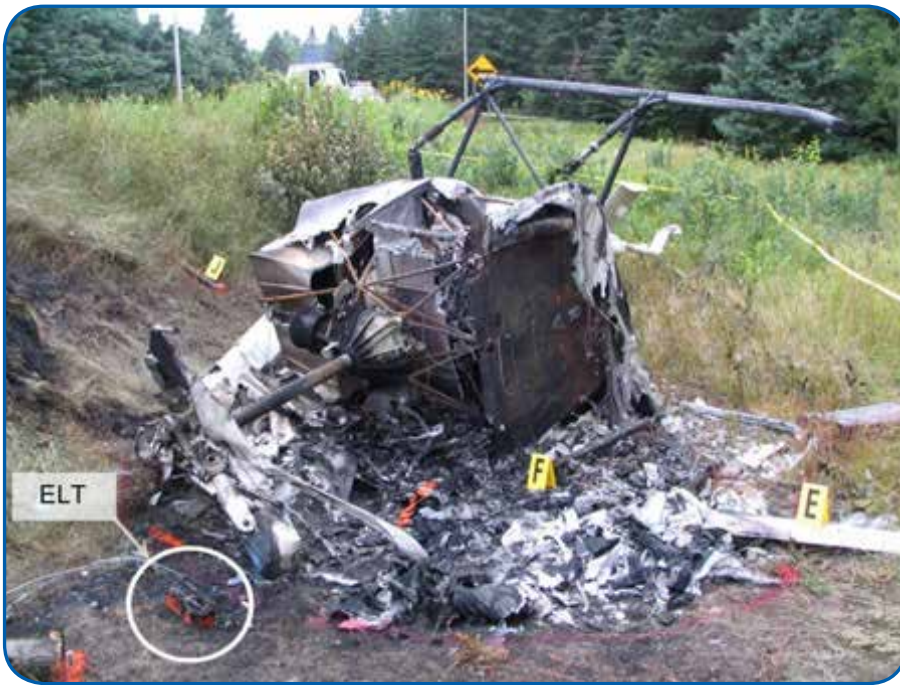
Wreckage of private Enstrom F-28C helicopter

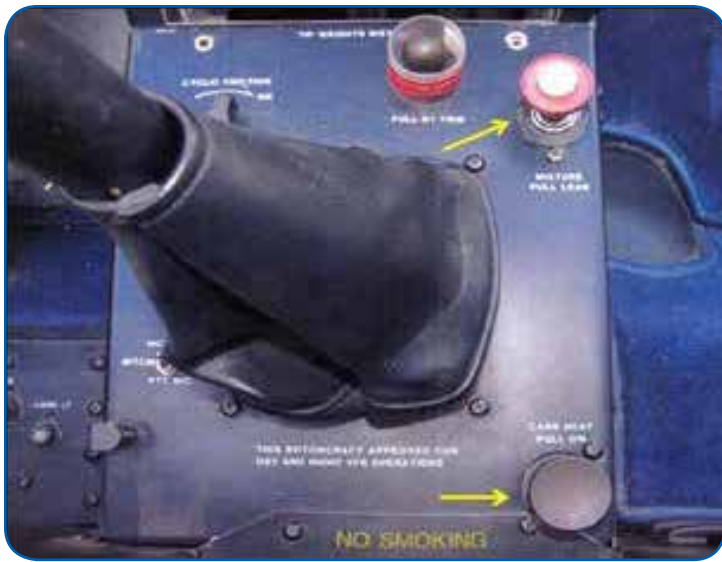
Photo 1: Mixture control top right and carburetor heat control bottom right

The fuel mixture and carburetor heat controls are located on the centre pedestal in close proximity to each other. To aid in identification, the control knobs are shaped differently. Furthermore, the fuel mixture control knob is red while the carburetor heat control knob is black (Photo 1). To prevent inadvertent deployment in flight, the manufacturer's checklist directs the pilot to place a removable cylindrical plastic guard over the mixture control knob before starting the engine (Photo 2). This guard is not to be removed until engine shutdown when the mixture control knob is pulled to the idle cut-off position (Photo 3). This plastic guard is not permanently attached to the control panel.

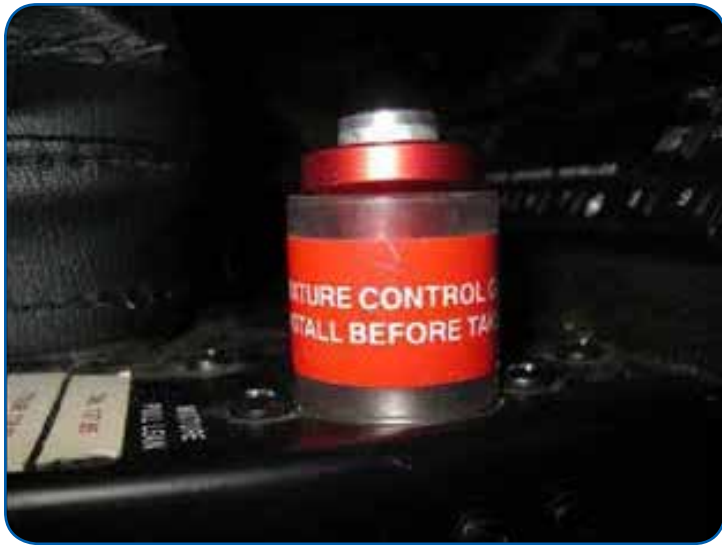
Photo 2: Mixture control with guard installed

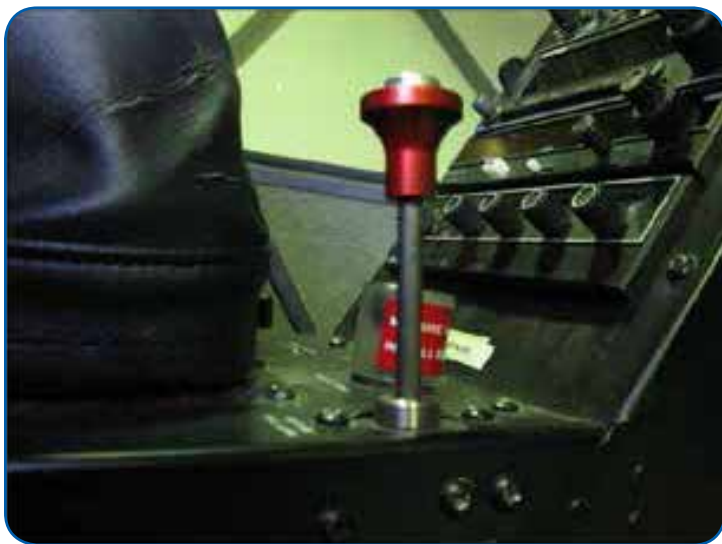
Photo 3: Mixture control in idle cut-off position

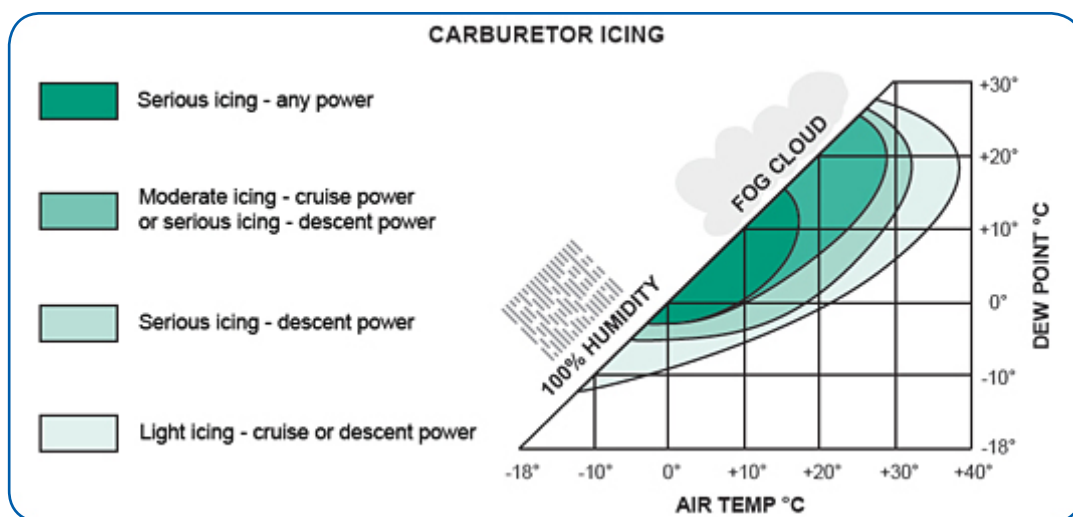
Carburetor icing probability chart

The weather conditions at CYKF were highly conducive to carburetor icing. In addition to the temperature/dew point spread, the operation conducted over wet grass would have intensified the rate of ice accumulation.

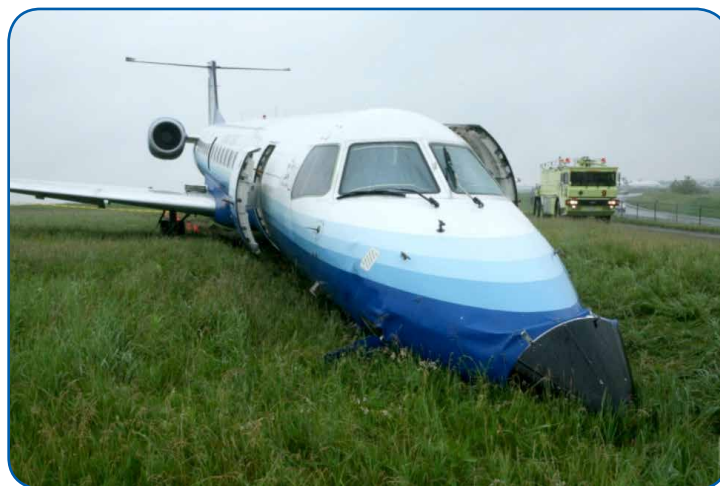
*The EMB-145LR following the occurrence*

8. The aircraft overran the runway threshold and the runway strip and subsequently encountered a significant dip, where the nose landing gear folded rearward, resulting in substantial damage to the nose of the aircraft.

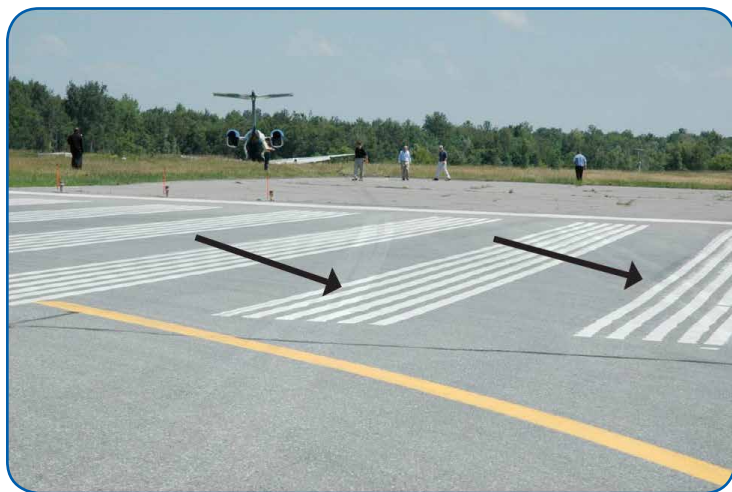
Steam cleaned marks observed on the departure end of Runway 07

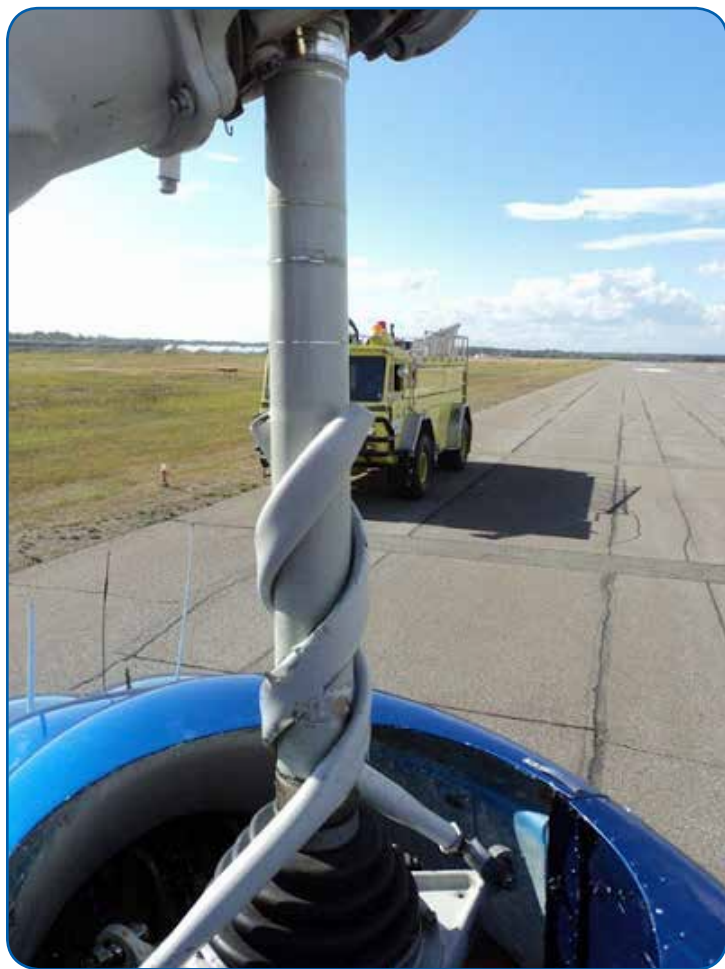
*Mast and pitch links*

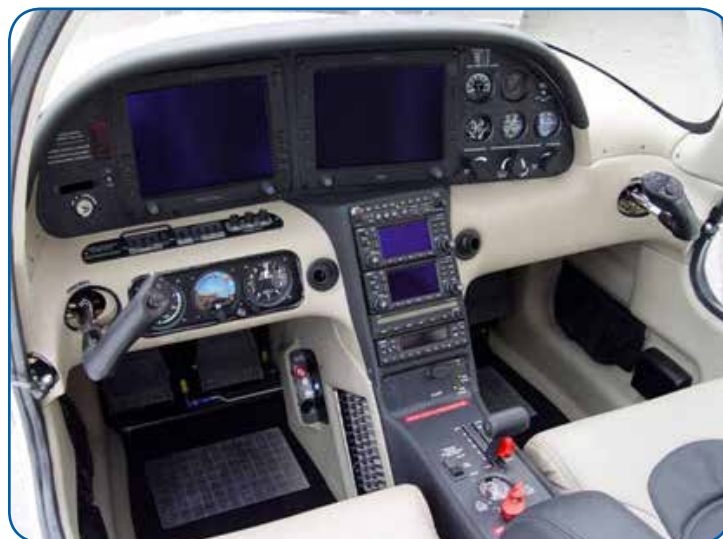
*Cockpit and flight controls of an SR22*

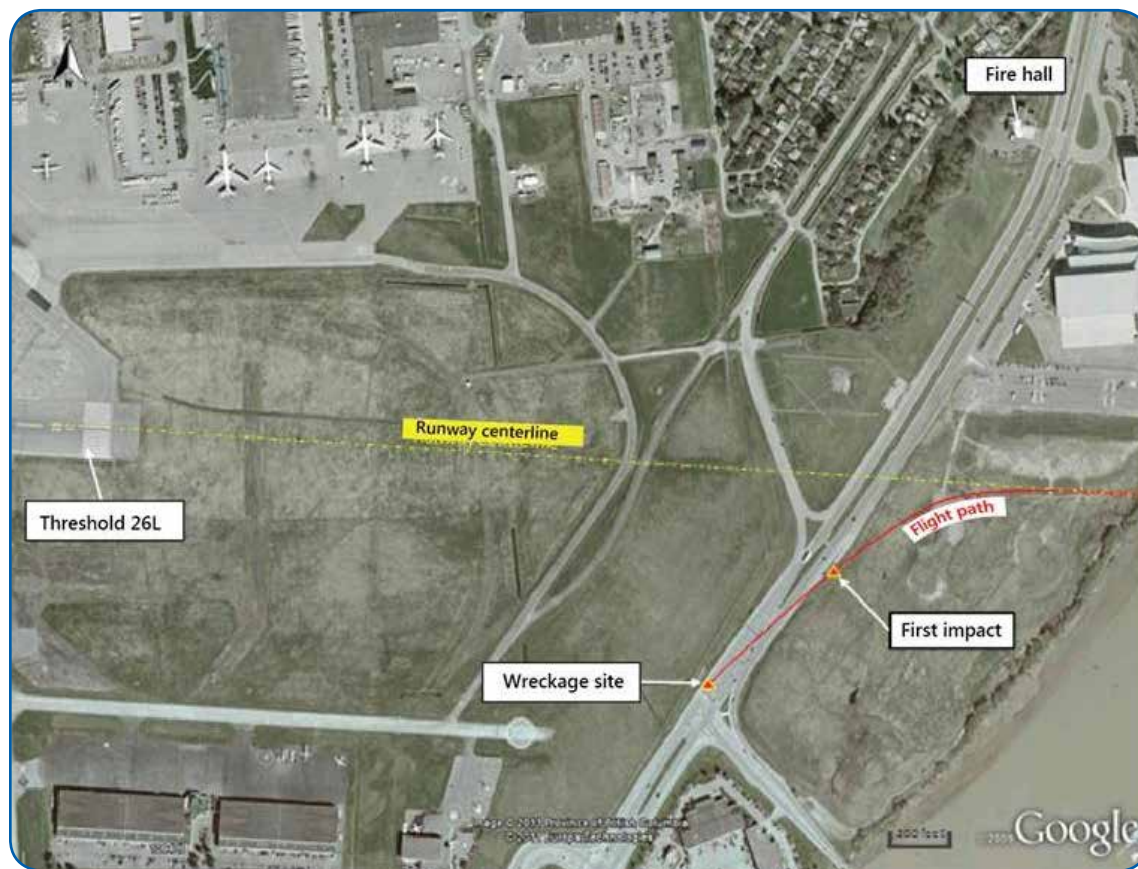
Enlarged diagram of final flight path

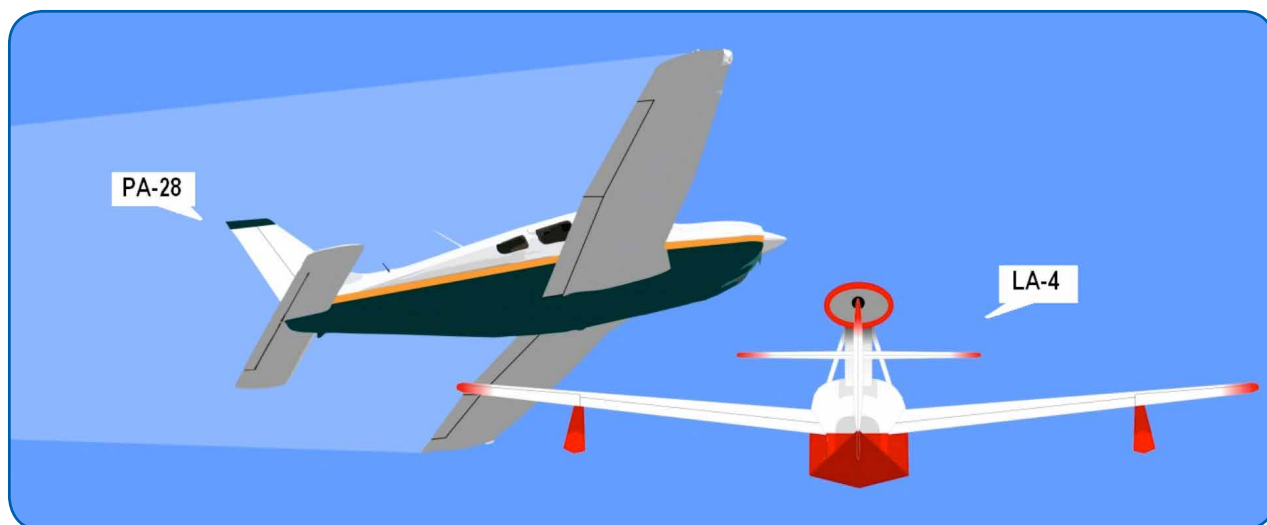
*Relative positions of the aircraft at impact*

Inspection of the damage to both aircraft left wings and ailerons indicated that the pilot of the PA-28 might have banked to the left, turning northward and away from the LA-4. This type of evasive action would have resulted in the PA-28's left wing being down to the point where it could only have come in contact with the left wing of the LA-4. A reconstruction of the likely aircraft positions at impact was prepared (see image above). The left outboard wing sections came to earth very close to each other and away from both main wreckage sites.

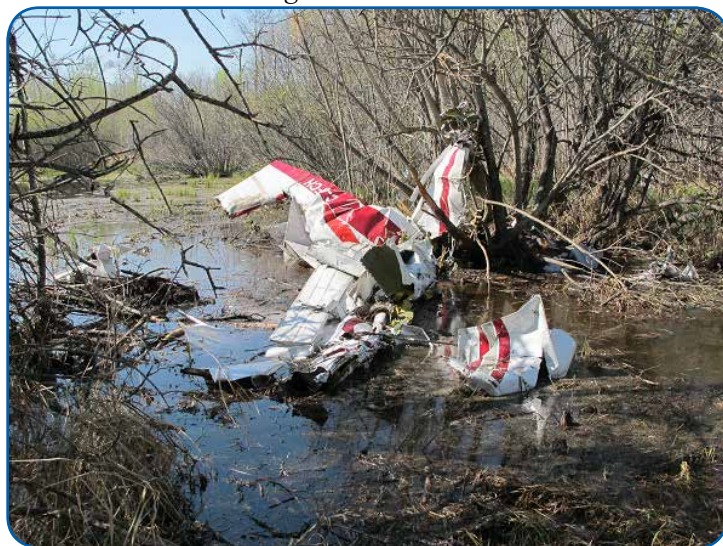
*Wreckage of the Lake LA-4 200 in a marsh*

- they were shorn off in the air at the time of the collision;
- either one or both of the aircraft had initiated some sort of turning avoidance manoeuvre; and
- because of the structural damage, both aircraft would have been uncontrollable after the collision.
