TP 185E
Issue 3/2011

AVIATION SAFETY LETTER

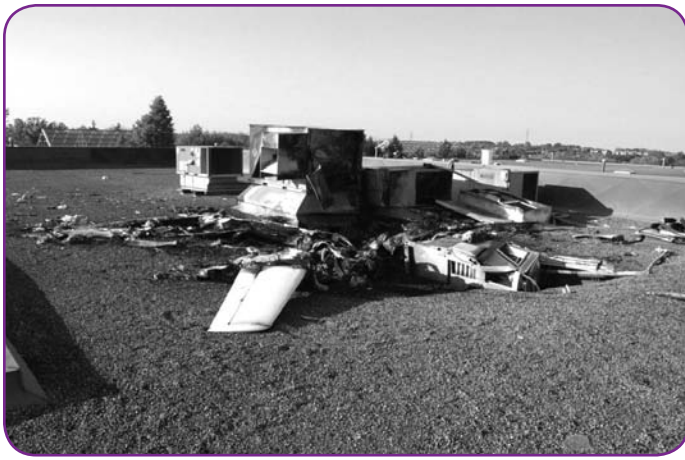
Picture of the accident scene when the ballistic parachute system deployed from within the aircraft wreckage.

The Cirrus SR20 aircraft is equipped with an airframe-mounted emergency parachute system, which had not been deployed in this occurrence. The Cirrus Airframe Parachute System (CAPS) is designed to lower the aircraft and its passengers to the ground in the event of a life-threatening emergency. Approximately 15 minutes after impact, there was an explosion as the rocket from the CAPS ignited from the heat of the fire. Still partially tethered to the airframe by stainless steel cables, the rocket ricocheted across the roof before breaking free of the cables and landing in the street approximately 165 ft from the crash site.

In its final report, the TSB made the following finding:
 “The Cirrus Airframe Parachute System activated post impact as a result of the post-crash fire and the rocket projectile landed in the street. Unless first responders are aware that some aircraft may be equipped with ballistic projectiles, and are trained in how best to deal with them, they will be placed at risk if there is ignition.”

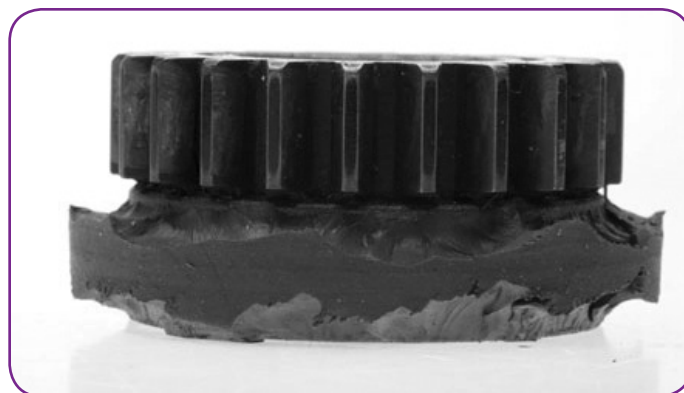
Photo 1. Gear damage to rubber material

This washer was found to have forced the rubber ring further out of the cup and engage the gear teeth of the crankshaft alternator drive gear. This resulted in the destruction of the rubber portion of the coupling. Rubber particles of various sizes found their way into the engine sump (see *Photo 1*).

The rubber particles found in the engine sump matched those of the old coupling. In addition, several of the lifters contained rubber debris, indicating that the oil filter had been in a bypass state, allowing debris to flow into the system. The oil filter was also found to contain a large amount of rubber and metal debris. When the coupling was changed, the engine oil and filter were not changed, nor was the engine oil system flushed. The engine

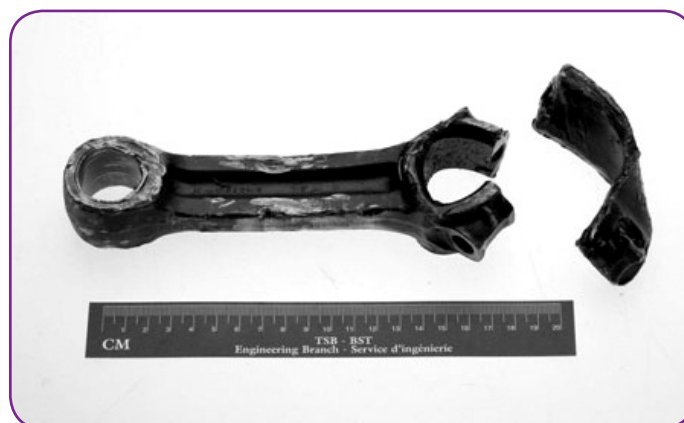
Photo 2. Heat and contact damage to connecting rod 2

The top of the engine at centreline had a large hole over the number two connecting rod. The crankshaft and the number two connecting rod had indications of extreme heat, which was localized to this area (see *Photos 2 and 3*). The number two main bearing on one side was broken due to low-cycle pounding stresses. The number two piston had been making contact over time with its cylinder head and valves.

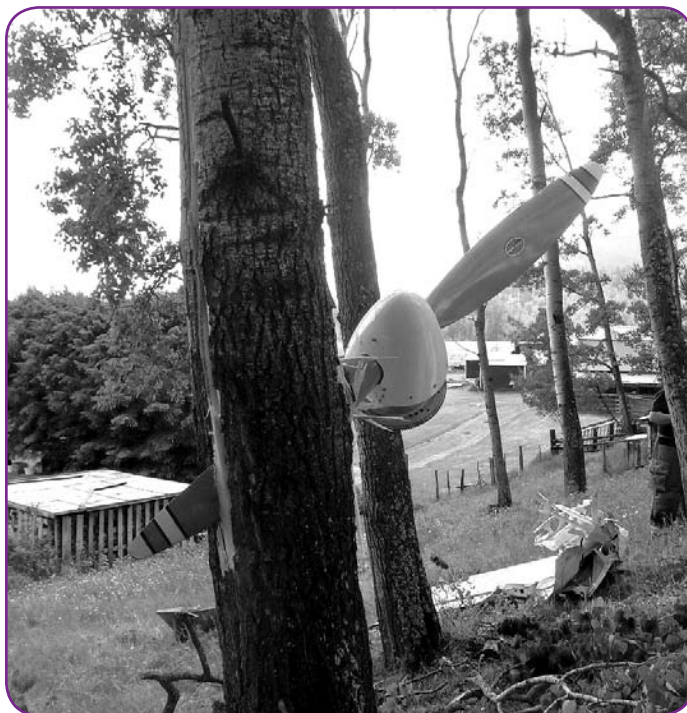
Photo 2: Propeller from the Glastar

The engine crankshaft sheared at the propeller hub and the propeller was found embedded in a tree at the accident site (*see Photo 2*). The propeller was nicked and scuffed in a manner consistent with striking the severed power line.
