Transport
Canada

TP 185E
Issue 4/2007

AVIATION SAFETY LETTER

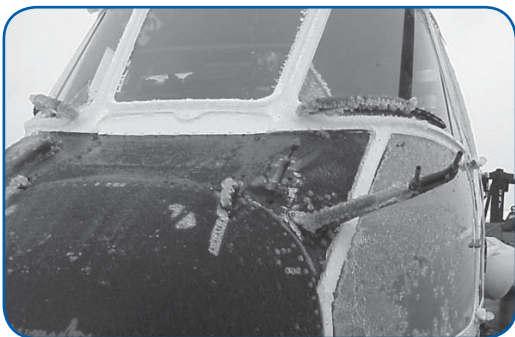
Front left of Puma with ice accretion

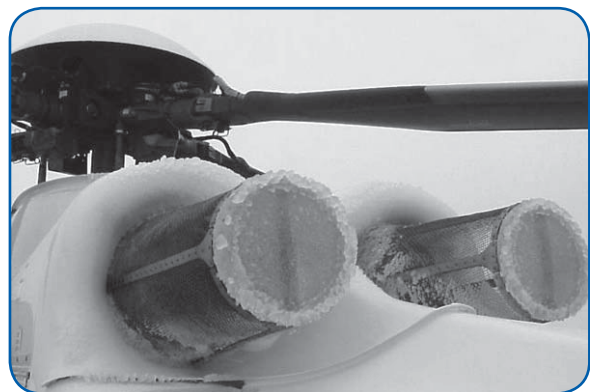
Air intakes iced-up with clean blades

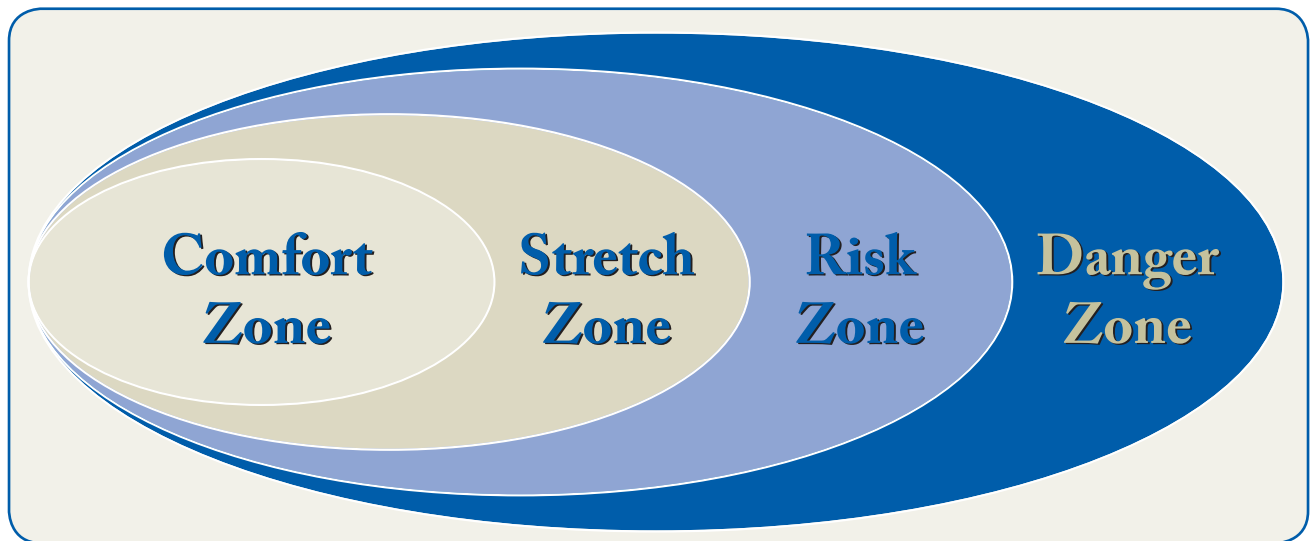
Figure 1: The comfort zone principle

The comfort zone model illustrates how challenging situations can have both positive (expanding) and negative (reducing) effects upon a participant's personal view of their own experience. The large goose egg represents a pilot's overall total knowledge, skill, and experience. The comfort zone represents one's personal level of satisfaction with the risks in flying. These are the elements of safety that protect us and make us feel comfortable. As long as pilots operate the glider within their personal comfort zones, they should be able to conduct the flight safely. The stretch zone represents flying activity that is beyond their normal experience and skill level, and therefore, outside their normal comfort area. Flying in this range under supervision can be safe. However, the new experience will develop a pilot's capabilities, introducing them to new experiences, skills, and knowledge. The risk and danger zones illustrated are beyond the pilot's normal range of capabilities; flight exercises attempted in these zones may not have suitably safe outcomes. Based on the law of primacy, if the instructor

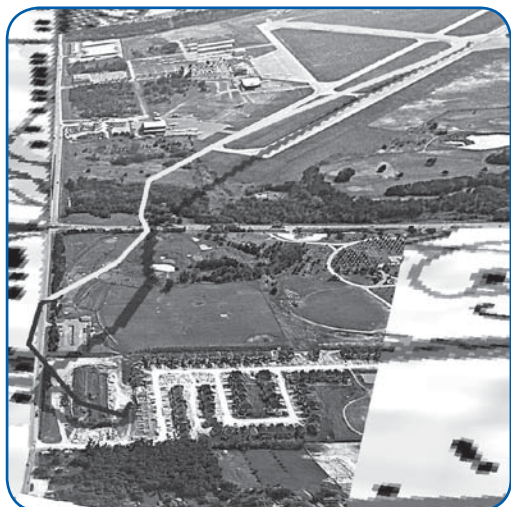
*Ground and flight path of occurrence aircraft,
as illustrated in the TSB Final Report*

On June 25, 2005, a Progressive Aerodyne, Inc. SeaRey amphibious aircraft (referred to here as SR 1) was taking part in the Canadian Aviation Expo at the Oshawa, Ont., airport. The flight was planned as part of a two-plane demonstration with another SeaRey aircraft (SR 2). The plan was to take off in formation, with the SR 1 leading, climb to 1 000 ft above ground level (AGL), turn left, and join a left downwind leg for Runway 30. When south of the airport, the aircraft were to split and perform a coordinated series of non-aerobatic manoeuvres that had been briefed and practised. Before takeoff, SR 1 had radio problems, so SR 2 led the takeoff, and SR 1 was in a right-echelon wingman position. The aircraft were cleared to take off in formation on Runway 30 from the intersection of Runway 04/22. After takeoff, the lead aircraft climbed out the extended centreline of the runway. SR 1 made a left turn as if leaving the formation toward the southwest, then turned to the right to again follow the lead aircraft. SR 1 then pitched nose up, and appeared to stall and spin to the left. The propeller was turning as the aircraft descended. The aircraft continued in a descending turn to the left until it struck the ground in a residential construction area. The aircraft was destroyed, and the pilot was fatally injured. There was no post-impact fire.
