TP 185E  
Issue 4/2008

# AVIATION SAFETY LETTER

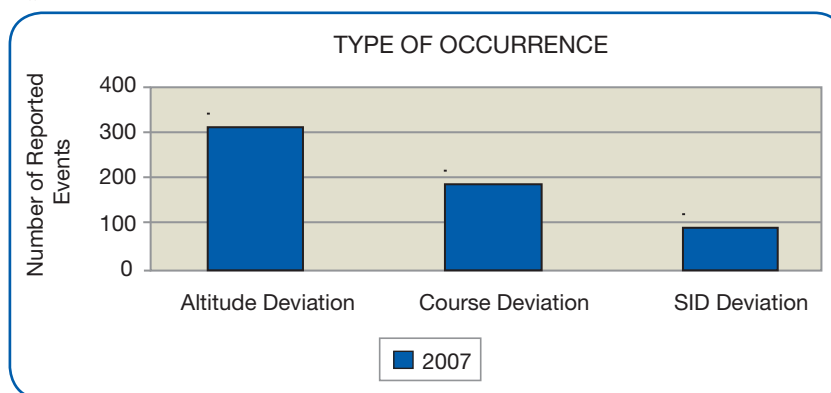
The chart below illustrates the national picture in 2007 of some of the events being tracked by NAV CANADA as reported through its Aviation Occurrence Reporting (AOR) system, which feeds Transport Canada’s Civil Aviation Daily Occurrence Reporting System (CADORS) database.

Although NAV CANADA tracks these issues, its ability to be proactive in mitigating them is quite limited, since an in-depth understanding of the “whys” behind these events requires input from other industry stakeholders. It is important to note that none of the events shown on the graph above resulted in catastrophic outcomes, thanks to the strength of the aviation industry’s defences. However, each time one of these events occurred, it pushed the safety envelope and occasionally required quick human intervention to re-establish safety.

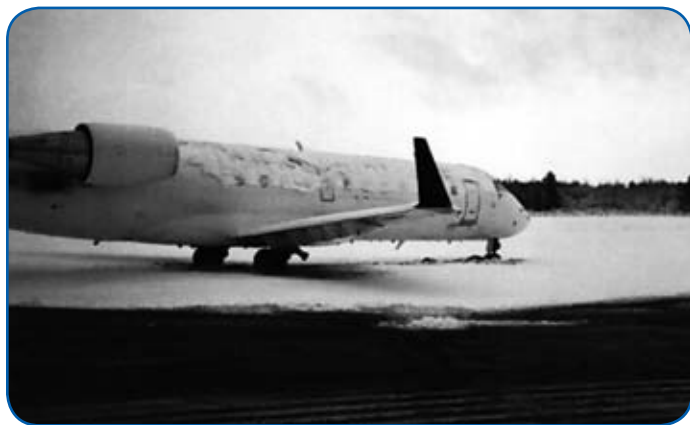
*Runway excursion due to slippery runway*

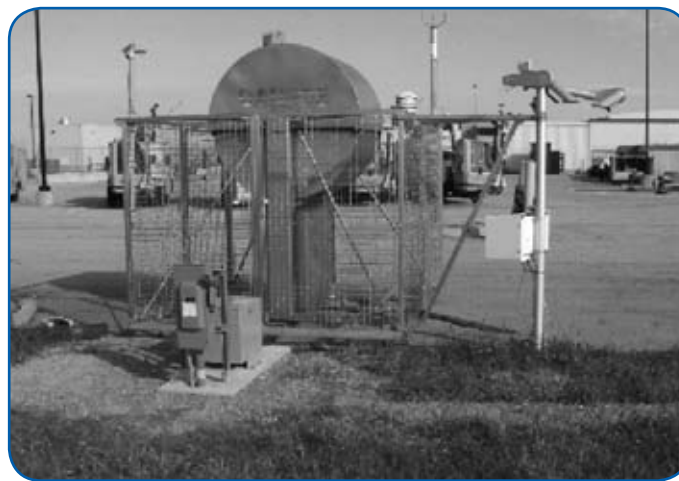
*D-ICE HOTDS equipment*

The HOTDS uses the regression curves and coefficients generated during the fluid endurance testing previously described in this article. The regression coefficients are published in a Transport Canada report. The current report only contains coefficients for the two fluids used at sites where the HOTDS is currently installed.

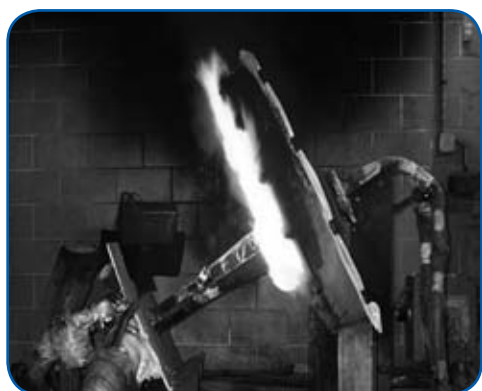
This segment provided an overview of the basis for the fuselage burnthrough requirement and reviewed the development of the oil burner test apparatus, followed by discussion of the development of a next-generation sonic orifice oil burner aimed at achieving higher testing consistency.

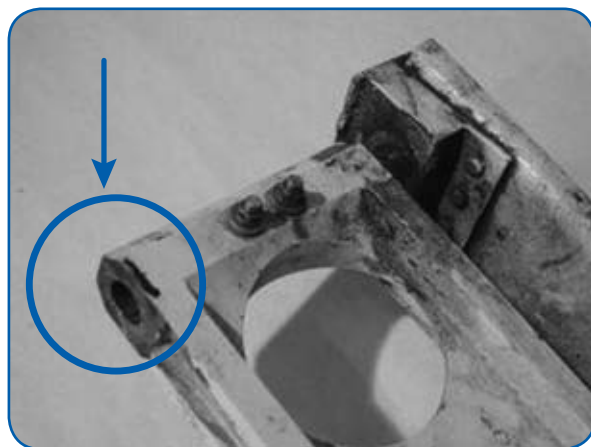
*Arrow points to where the missing left-hand upper drag brace attachment pin should have been*

Further investigation determined that the initiating source of the failure was traced to the left-hand upper drag brace attachment pin (P/N 50-820233 or 99-820110-9) that was missing and had not been properly secured to the drag brace assembly. The missing pin caused the transfer of loads to the right upper drag brace attachment fitting,

which fatigued and failed, passing the loads to the right intercostal rib. The rivets securing the intercostal rib to the wheel well began to pull from the sheet metal attachment point until failure occurred, and the landing gear collapsed.

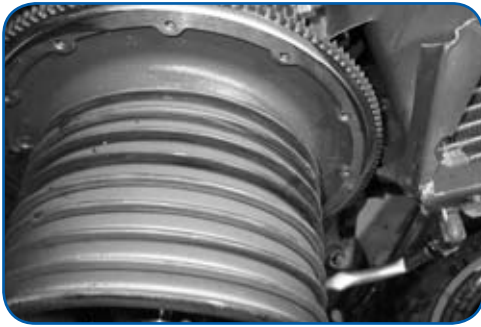
*This close-up photo shows the uneven wear and belt slip on the engine pulley sheave*

1. Galling on the engine-cooling fan taper-fit joint within the previous few hours of flight operations introduced vibration to the belt-drive system, which in turn caused the misalignment of the belts within the sheave grooves and led to two vee-belts running off the sheaves in flight.
2. The sudden loss of vee-belt tension caused the remaining two vee-belts on the driving sheave to slip, leading to a rapid loss of main rotor RPM. This, in turn, prevented the pilot from avoiding the trees and led to a collision with the terrain and the destruction of the helicopter.

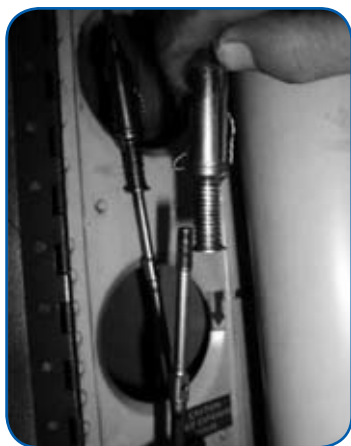
*Speed rig and cables as found*

1. The tail rotor pitch change cable speed rigs were not lock-wired in accordance with approved methods. As a result, one cable speed rig came undone, and tail rotor authority was lost.
2. The independent control inspection was not carried out in accordance with the standards described in the *Canadian Aviation Regulations* (CARs) or relevant Airworthiness Notice (AN), and the missing lock wire was not detected.

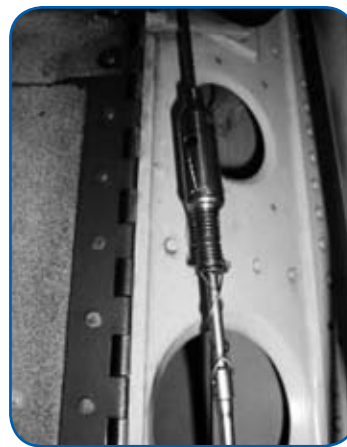
*Properly lock-wired speed rig*

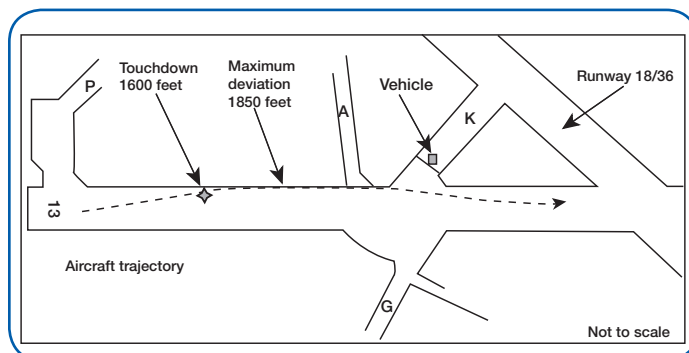
*Overhead view of Runway 13 and aircraft trajectory*

The aircraft touched down firmly approximately 1 600 ft from the runway threshold and well-left of the runway centreline. During the rollout, the left landing gear tracked briefly outside of the runway edge lights on the left side of the runway. Two of the runway edge lights were broken. One tire of the left wheel set sustained a cut and was replaced. There was no other damage to the aircraft, and there were no physical injuries.

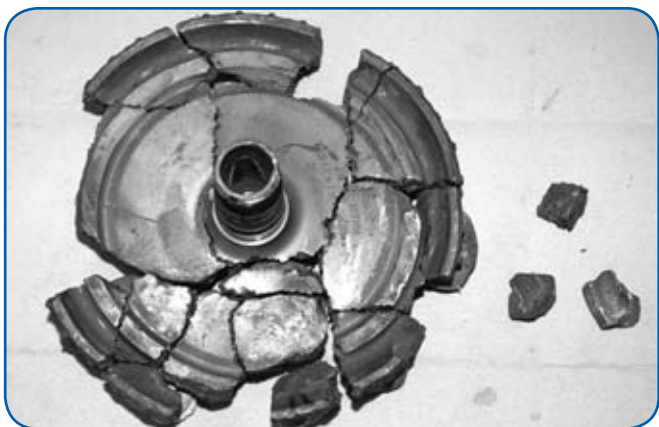
*First-stage wheel damage due to overspeed*

1. The area adjacent to bearings 6 and 7 had exceeded a temperature of 900°C. The bearings were destroyed for undetermined reasons, causing an engine failure.
2. Moving the helicopter towards the road when the engine was showing signs of malfunction contributed to the failure of bearings 6 and 7.
3. During the autorotation, the helicopter was not levelled at the time of the landing, which resulted in a hard landing.

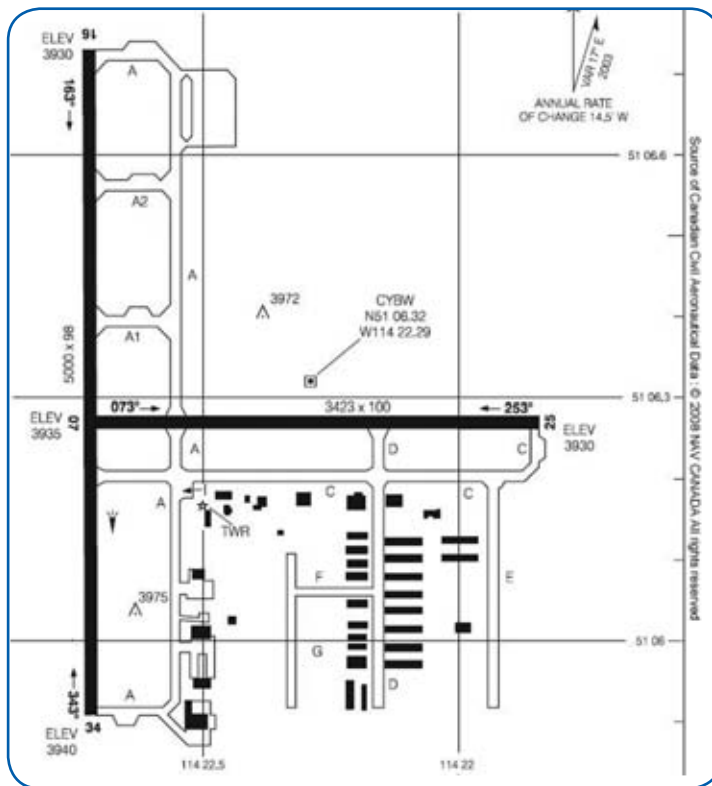
Portion of the Calgary/Springbank aerodrome chart  
with both runways clearly marked  
**NOT FOR NAVIGATION**

The captain requested the departure clearance from the Springbank ground controller at 10:36 MDT. The clearance given was for a departure off Runway 25. The controller advised that Runway 34 was available; however, the captain accepted Runway 25. The runway length for Runway 25 (3 423 ft) was not given to the crew by ATC, nor was it required. A revised TOLD card for Runway 25
